City of Waco
Tax Increment Financing (TIF)
Application

Cameron Hall and Courtyard

Cameron Summer House

- WE Project No. 2017-062
- November 28, 2017

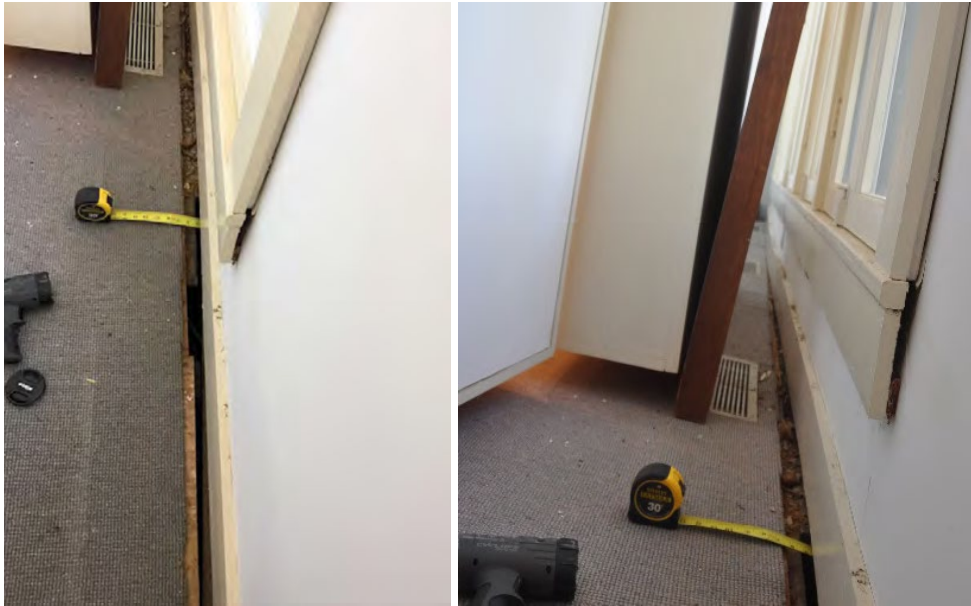
Figure 7. Cameron House Interior (2-3 inch gap in the first-floor decking)

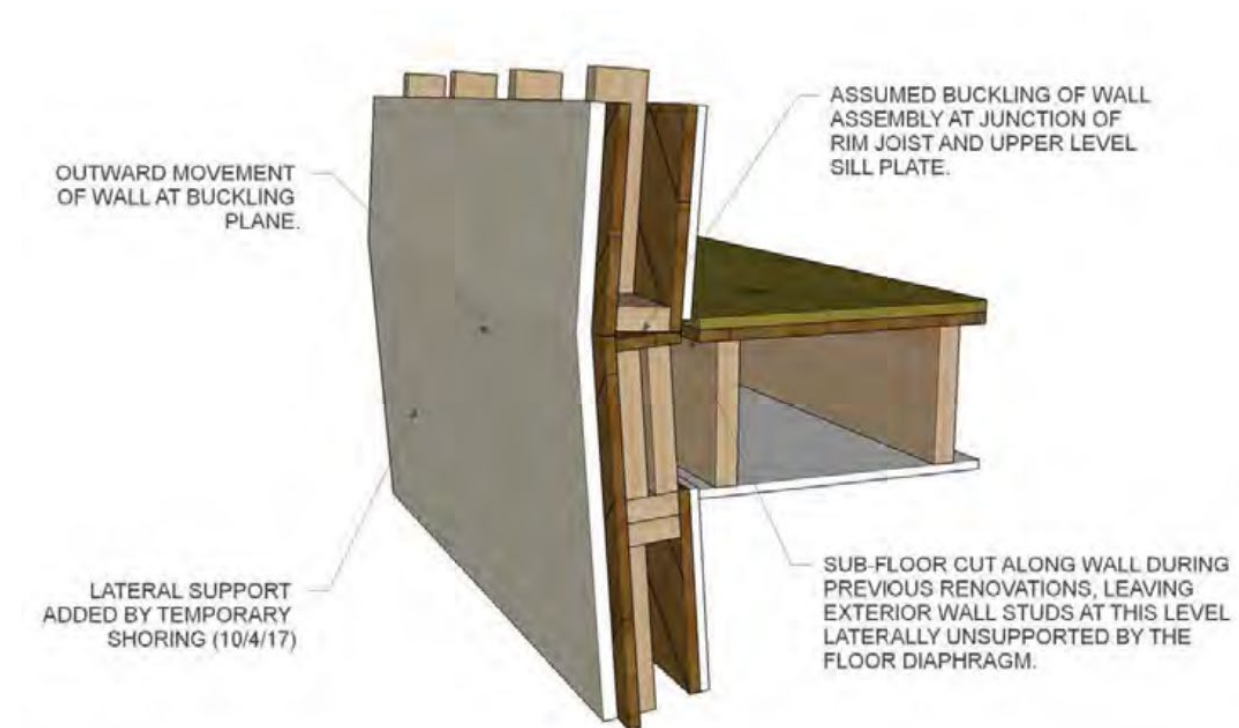
Figure 8. Diagram showing movement of the floor and walls

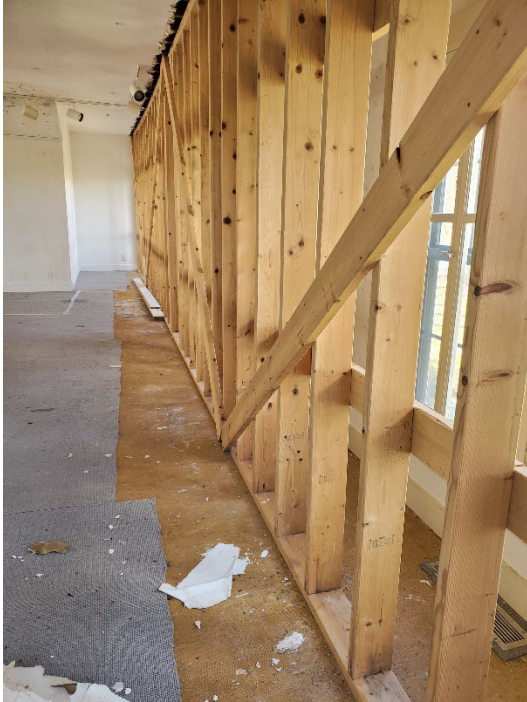
Figure 9. Cameron House Interior (Temporary support installed to stabilize the structure)

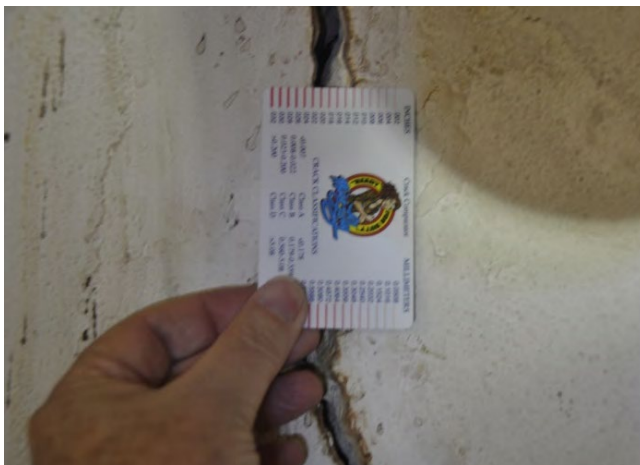
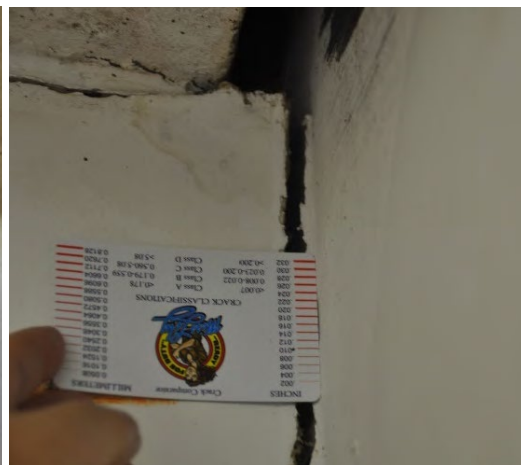
Figure 12. Cameron House Interior (various cracking)

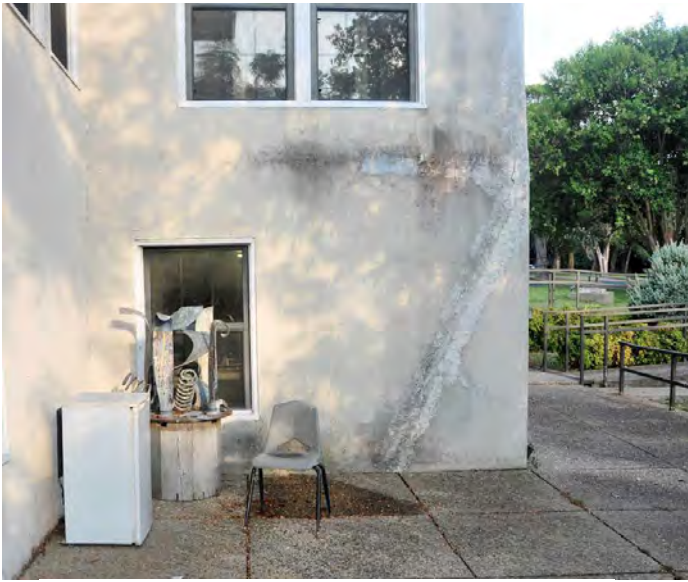
Figure 5

of the cracks. However, it was also observed that no control joints were present in the exterior stucco.

Control joints help to relieve stresses which occur due to normal expansion, contraction, and movement of the building. Without these joints, stucco cracks may eventually form at points of natural weakness.

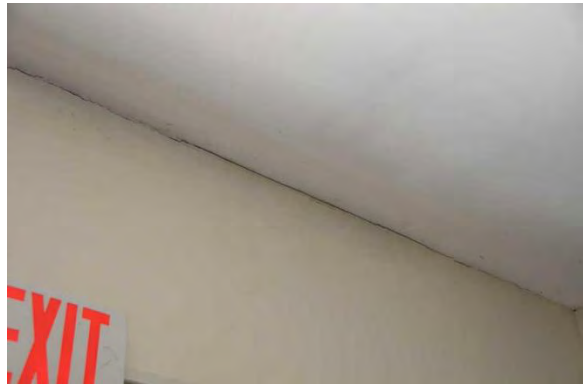
Figure 7

Visual Observations, Interior - Minor cracks, crazing, and/or separations in sheetrock walls and ceilings, as well as door and window frames, are present in many of the interior spaces (see Figure 7). Items of this type can be categorized in general as typical in a wood framed building of similar age and construction. Primarily cosmetic in nature, these type cracks do not necessarily indicate more serious structural concerns, and can be addressed on an as-needed basis with minimal repairs.

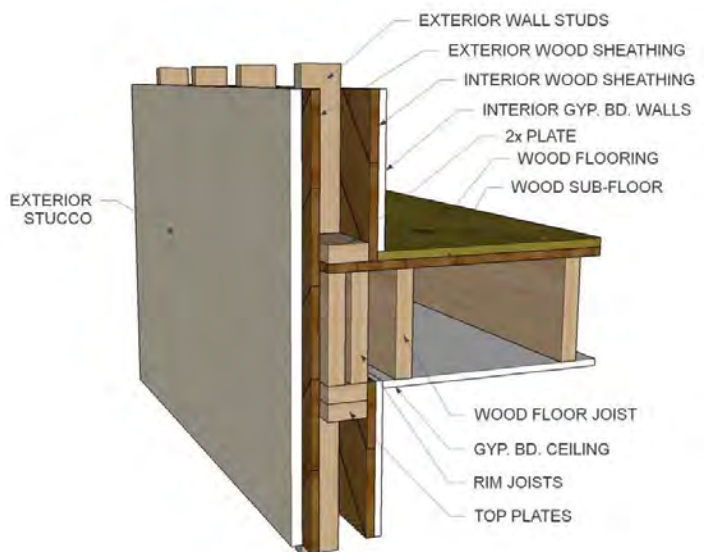
Figure 12

Typical wood construction techniques would have employed load-bearing wood stud walls at the first-floor level supporting exterior rim joists, and in-turn a similar load-bearing wall above (see Figure 12). The wood floor decking would have extended continuously under the second-floor 2x sill plate, tying the wall to the main floor diaphragm at that point to provide lateral stability. The initial assumption by Winton Engineering was that the first-floor wall, separated from the main structure when the floor decking was cut, had over time simply shifted laterally outward.

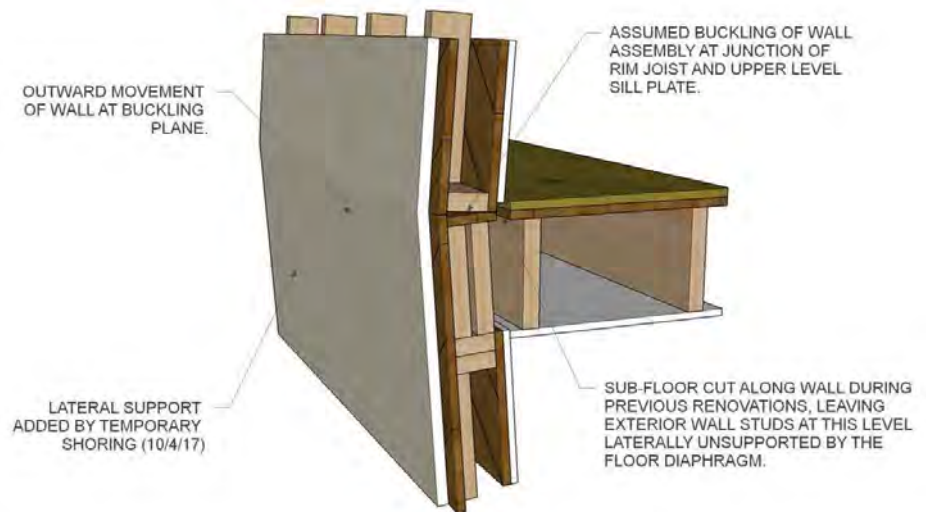
Figure 13

Initial wall movement of this type might be attributable to large lateral loads such as an extreme wind event, to foundation movement, or to other lateral load sources such as the movement of people, equipment or furniture above. Once the movement begins however, the weight of the structure above ceases to be applied axially to the wall studs below, but instead begins to create secondary forces which tend to push the wall further outward (see Figure 13).

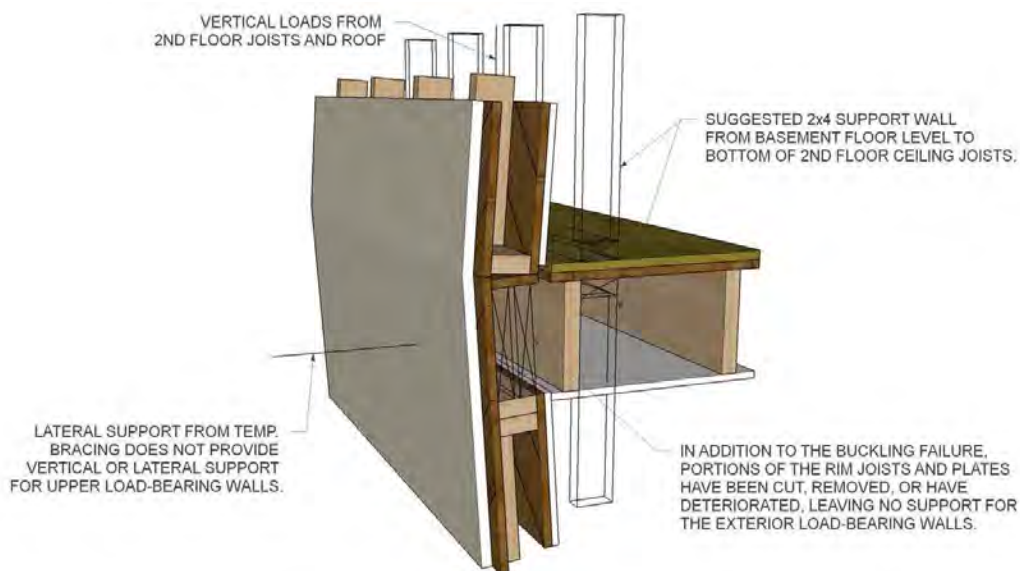
Figure 14

Removal of the additional finishes revealed not only the outward movement of the lower wall studs, but also that portions of the supporting top plates had deteriorated. Portions of the supporting exterior rim boards had also been damaged or removed during previous renovations and/or utility work. In some locations, it appeared the entire weight of the upper floor and roof structure were now being supported primarily by the exterior wood sheathing (see Figure 14). A temporary load-bearing wood wall system extending from the foundation level up to the bottom of the existing roof trusses was thus recommended by Winton Engineering, and subsequently installed by Barsh Construction.

An on-site review of the temporary wall system was made on November 21, and at that time the structure at the rear wall appeared to be stabilized. No unsteadiness was observed.

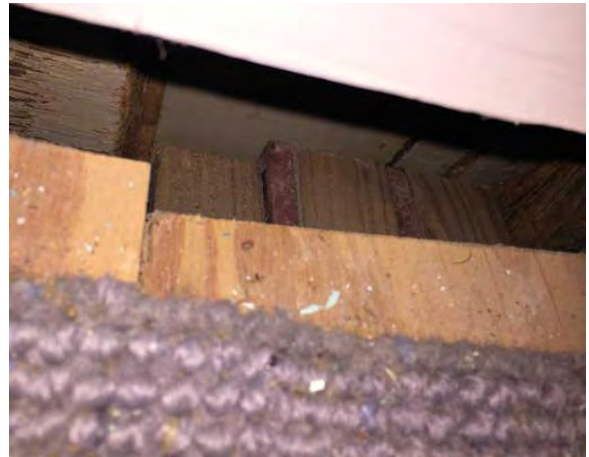
Figure 15

First-Floor Settlement – Settlement along the rear wall was observed during the initial September 18 site observation. Floor elevation readings taken during the visit indicated an elevation difference of approximately minus four inches at the low point.¹² During the inspection of the floor gap at rear wall, the end of a suspected 2x steel flitch-plated beam was observed (see Figure 15).

Selected finish removal made during the October 2 site observation revealed that the suspected beam was in-fact in place, and was supporting the main 2x first-floor level floor joists at this location.

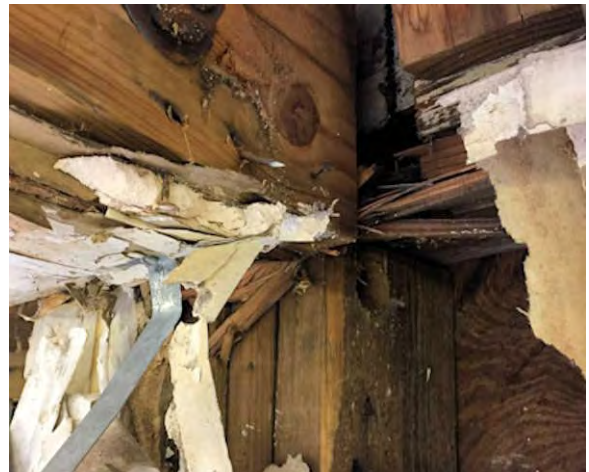
Figure 16

Additional finish removal made by Barsh Construction during the November 6 visit revealed that the supporting wood plates below the beam had largely deteriorated, the beam had dropped, and the supporting wood wall had shifted outward (see Figure 16). It appeared that the beam had approximately 1/2-inch or less of structural support remaining at the time of installation of the temporary steel column. Floor settlement along the rear wall was an obvious result of the loss of support and subsequent settlement of this beam.

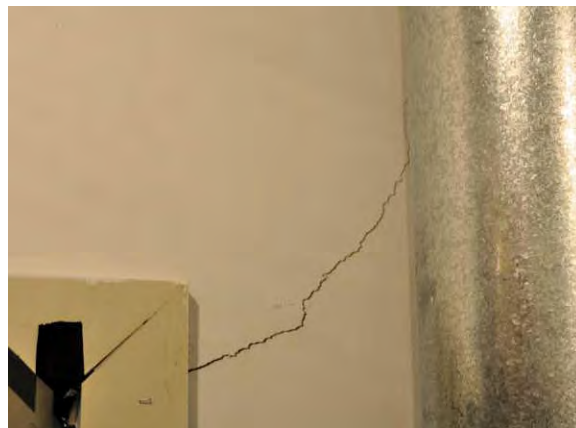
Figure 17

The floor settlement was noticeable during the September 18 site observation; predominantly a downward slope toward the wall separating the **men's restroom** from the counter/sink area, and in the darkroom. The door to the darkroom was difficult to open, and significant settlement cracks were observed in the darkroom itself (see Figure 17). Results of the floor elevation study indicated the lowest floor elevation readings near the northwest corner of the restroom, along the wall common to the darkroom.

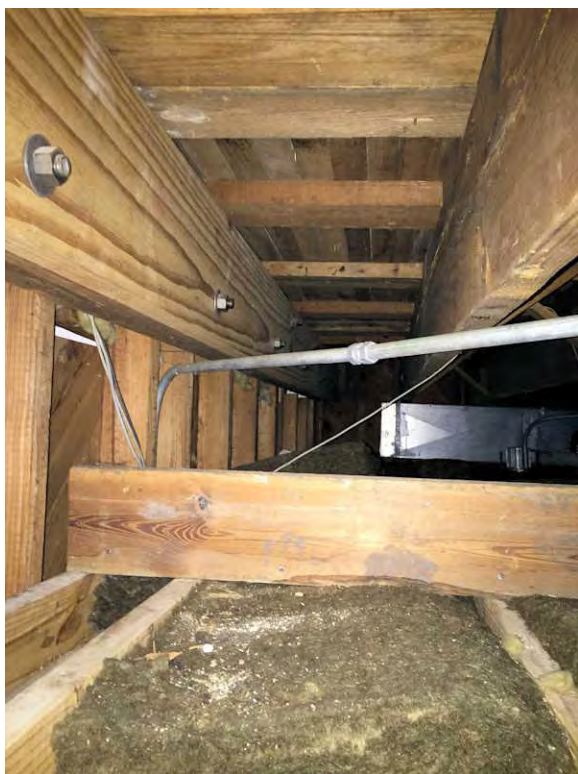
Figure 18

Access to the floor framing was provided on October 2, through the removal of a patch in the sheetrock ceiling located in the mechanical room below. Although views through the patched area were limited, it appeared that modifications to the original framing had been made. Additional finish removal by Barsh Construction on November 6 revealed several structural concerns.

A double 2x wood beam with a steel flitch-plate was observed running east-to-west and along the wall separating the mechanical room from the gallery to the north (see Figure 18). No visible support was observed at either end of the beam. It appeared that the beam may have been nailed or possibly lag screwed to the adjacent wall studs or an existing floor joist, however confirmation of such was not possible. The purpose of the beam is also unknown. It did not appear on the Waco Creative Art Center renovation plans¹⁴, and without end support the need for the steel flitch-plate is uncertain. A possibility is that the beam was originally intended for another location, and repurposed here at a later date.

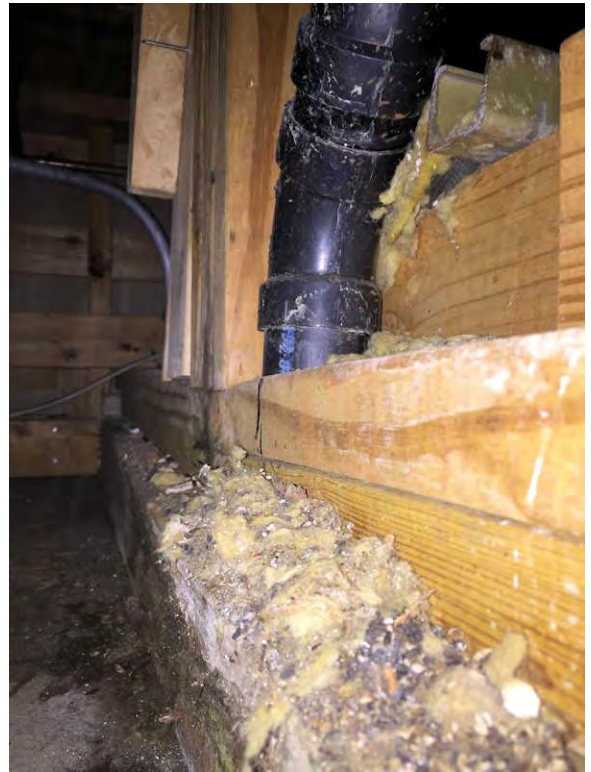
Figure 19

The top plates had been cored for the installation of a plumbing pipe immediately next to the 2x support posts. Finishes were removed from the wall directly below to reveal no studs or other structural support, leaving the 2x top plates to effectively carry the loads from the beam as a simple cantilever from a single stud support to the west.

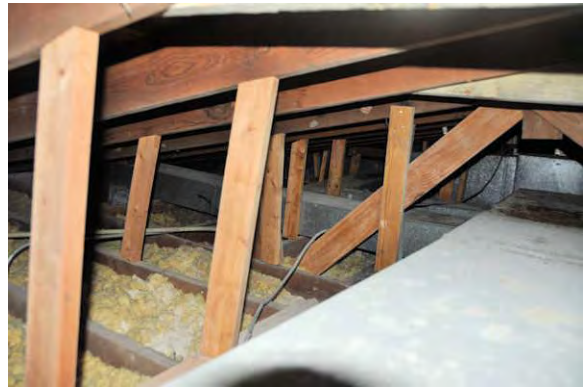
Figure 21

Attic Framing – The attic was accessed from a scuttle hole in a mechanical closet on the second floor. Abandoned HVAC equipment and ductwork limited access and visual observation, but several structural issues were observed. The attic framing members were generally sound, with minimal moisture damage or deterioration visible, however numerous “new” wood braces had been installed on top of the original ceiling joists (see Figure 21).

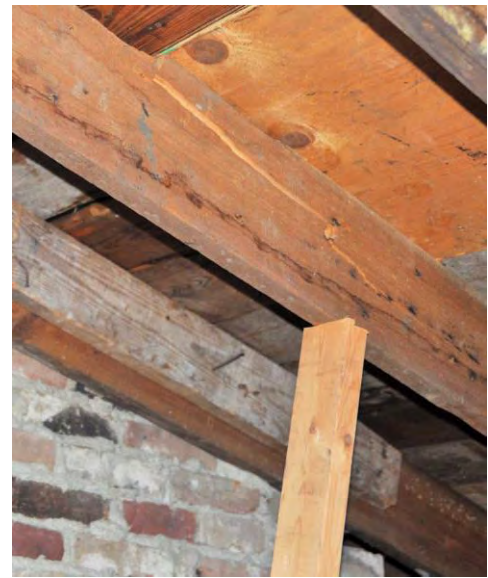
Figure 22

From a structural standpoint the conditions observed in the attic pose several concerns, in particular if the sagging roof structure **observed in the 1990's** was creep related. If the amount of creep in any roof rafter exceeded the deflection associated with the maximum loads that rafter is capable of safely supporting, then in order to remove the creep deflection the rafter had to be overloaded in the opposite direction. A rafter near the main fireplace was observed to have been cracked over an installed support (see Figure 22). The crack was near a knot in the rafter, a natural weak spot, and may simply have been the result of overloading the joist during the reroofing process. However, it is also a possible indication that considerable jacking force was applied to the rafter in the roof leveling process.
