City of Waco
Tax Increment Financing (TIF)
Application

Project Name: Cameron Hall and Courtyard

Cameron Summer House

- WE Project No. 2017-062
- November 28, 2017

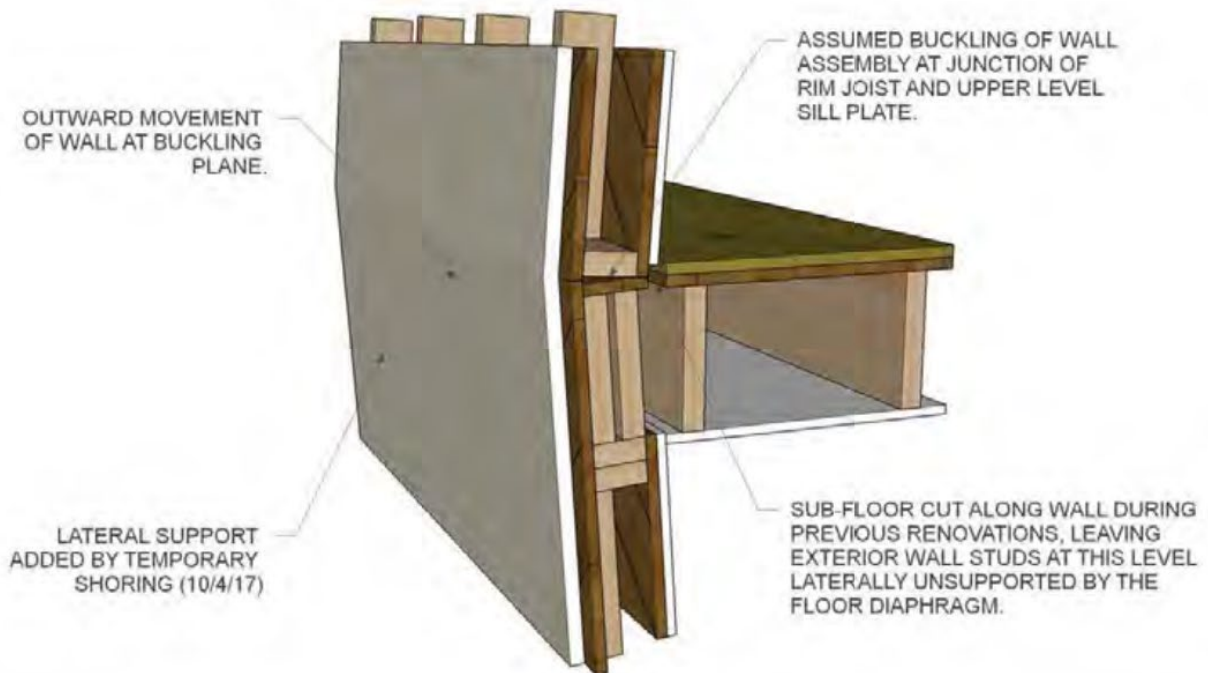
Figure 8. Diagram showing movement of the floor and walls

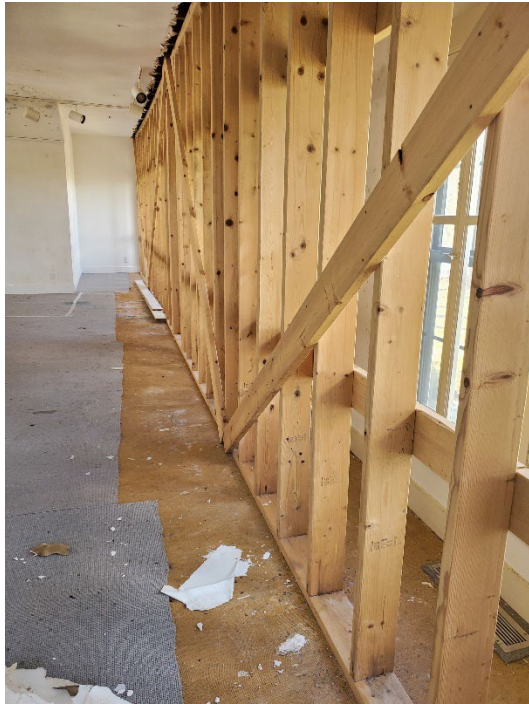
Figure 9. Cameron House Interior (Temporary support installed to stabilize the structure)

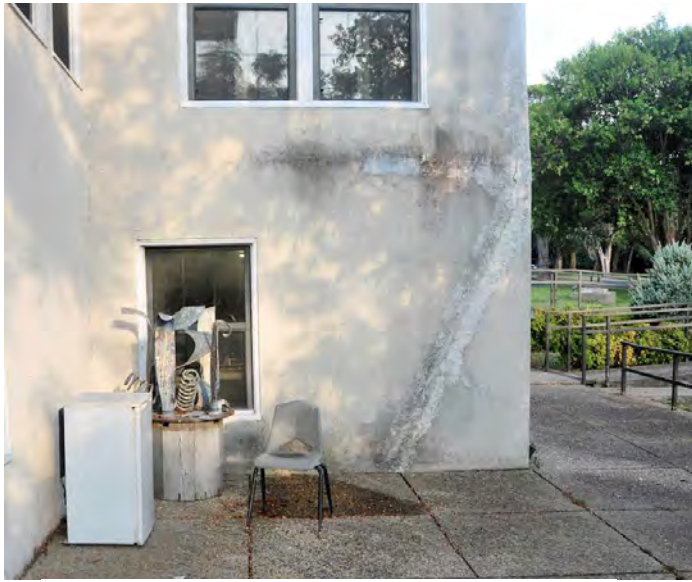
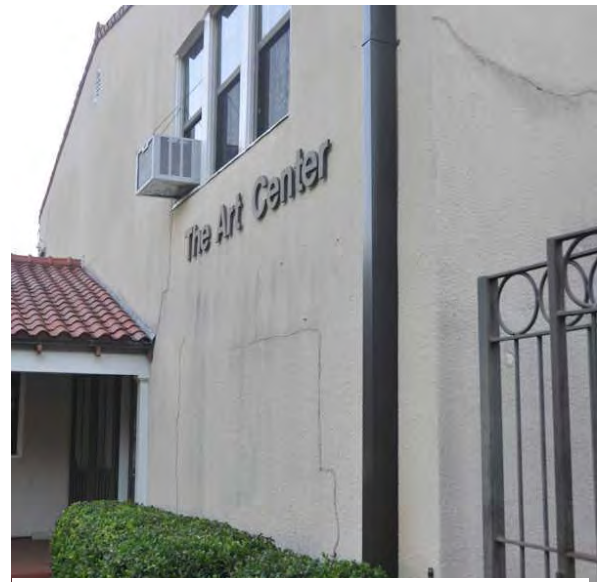
Figure 5

of the cracks. However, it was also observed that no control joints were present in the exterior stucco.

Control joints help to relieve stresses which occur due to normal expansion, contraction, and movement of the building. Without these joints, stucco cracks may eventually form at points of natural weakness.

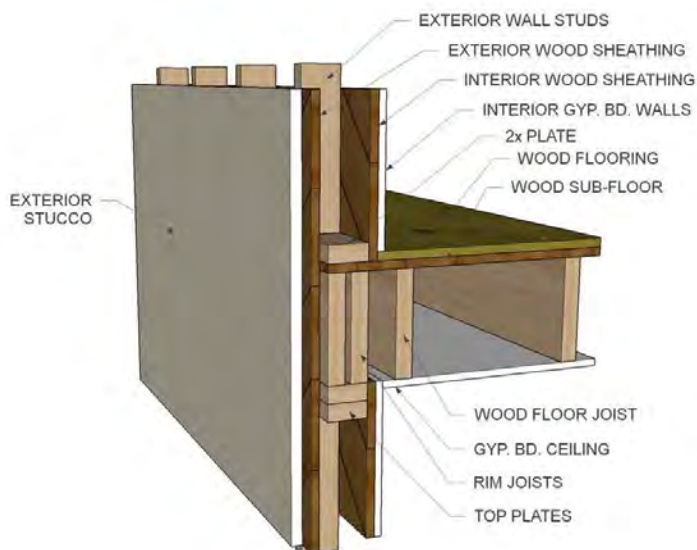
Figure 12

Typical wood construction techniques would have employed load-bearing wood stud walls at the first-floor level supporting exterior rim joists, and in-turn a similar load-bearing wall above (see Figure 12). The wood floor decking would have extended continuously under the second-floor 2x sill plate, tying the wall to the main floor diaphragm at that point to provide lateral stability. The initial assumption by Winton Engineering was that the first-floor wall, separated from the main structure when the floor decking was cut, had over time simply shifted laterally outward.

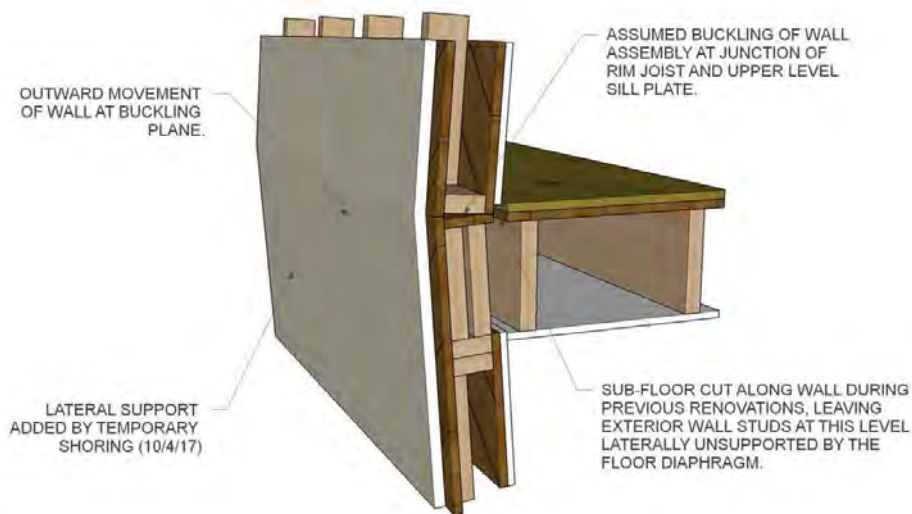
Figure 13

Initial wall movement of this type might be attributable to large lateral loads such as an extreme wind event, to foundation movement, or to other lateral load sources such as the movement of people, equipment or furniture above. Once the movement begins however, the weight of the structure above ceases to be applied axially to the wall studs below, but instead begins to create secondary forces which tend to push the wall further outward (see Figure 13).

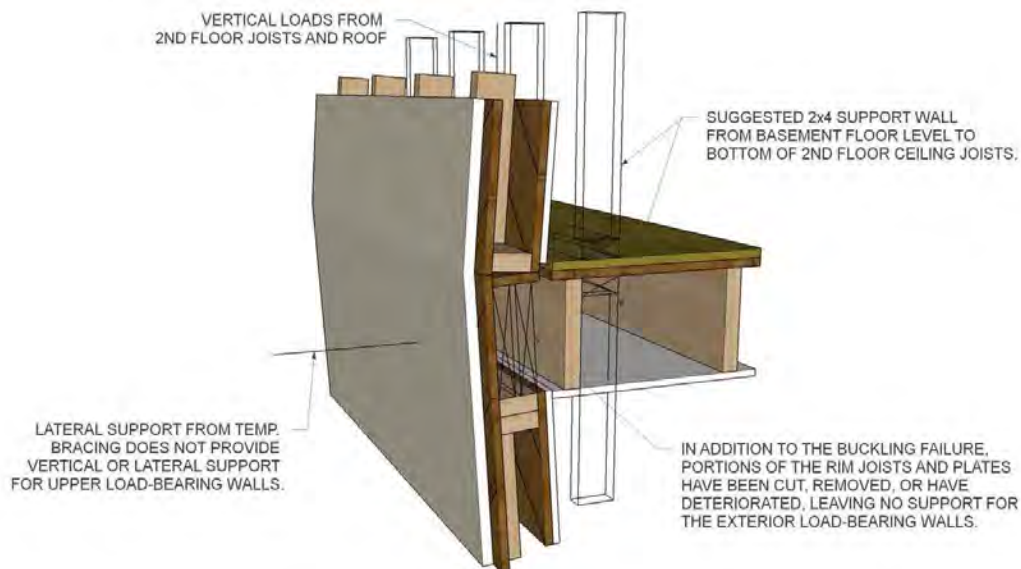
Figure 14

Removal of the additional finishes revealed not only the outward movement of the lower wall studs, but also that portions of the supporting top plates had deteriorated. Portions of the supporting exterior rim boards had also been damaged or removed during previous renovations and/or utility work. In some locations, it appeared the entire weight of the upper floor and roof structure were now being supported primarily by the exterior wood sheathing (see Figure 14). A temporary load-bearing wood wall system extending from the foundation level up to the bottom of the existing roof trusses was thus recommended by Winton Engineering, and subsequently installed by Barsh Construction.

An on-site review of the temporary wall system was made on November 21, and at that time the structure at the rear wall appeared to be stabilized. No unsteadiness was observed.

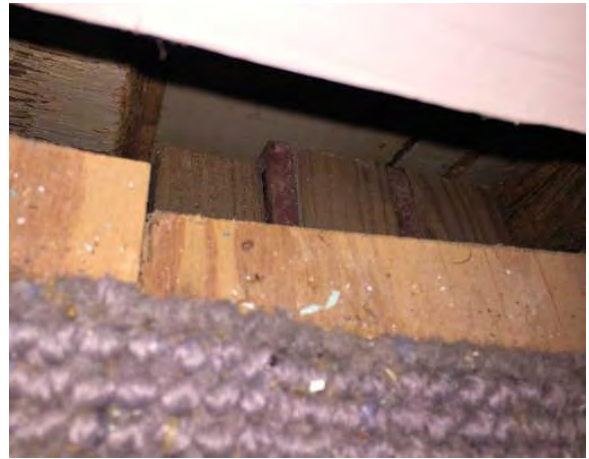
Figure 15

First-Floor Settlement – Settlement along the rear wall was observed during the initial September 18 site observation. Floor elevation readings taken during the visit indicated an elevation difference of approximately minus four inches at the low point.¹² During the inspection of the floor gap at rear wall, the end of a suspected 2x steel flitch-plated beam was observed (see Figure 15).

Selected finish removal made during the October 2 site observation revealed that the suspected beam was in-fact in place, and was supporting the main 2x first-floor level floor joists at this location.

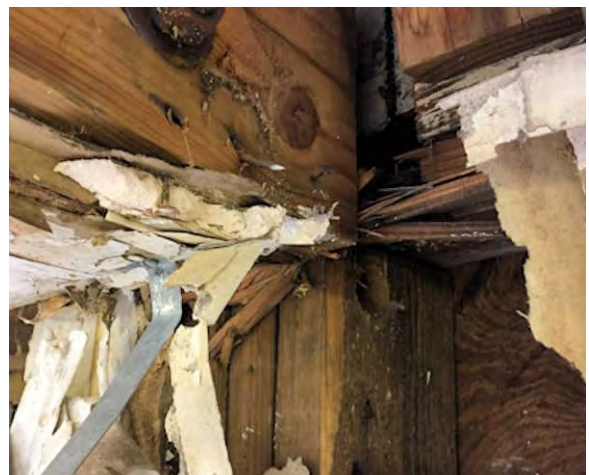
Figure 16

Additional finish removal made by Barsh Construction during the November 6 visit revealed that the supporting wood plates below the beam had largely deteriorated, the beam had dropped, and the supporting wood wall had shifted outward (see Figure 16). It appeared that the beam had approximately 1/2-inch or less of structural support remaining at the time of installation of the temporary steel column. Floor settlement along the rear wall was an obvious result of the loss of support and subsequent settlement of this beam.

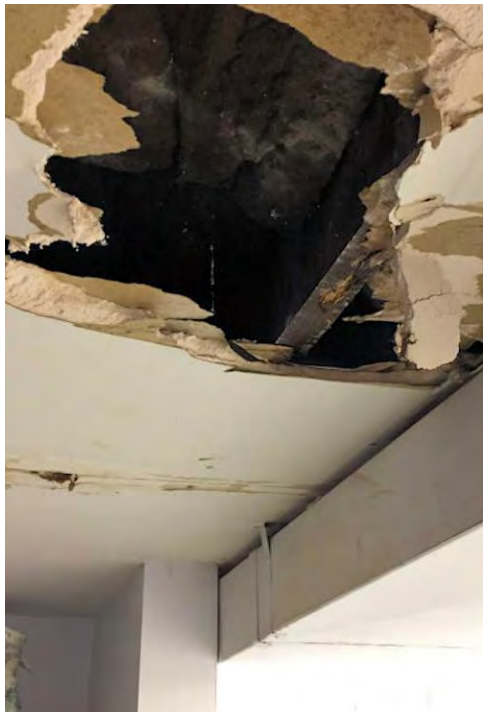
Figure 20

Following the load down to the lower levels, the supporting wall is located above an open area on the basement level. The 1974 renovation plans indicated that a new steel flitch-plated beam was to be installed below the wall. Partial removal of ceiling finishes in the basement revealed that no such beam was installed at the location (see Figure 20).
