City of Waco
Tax Increment Financing (TIF)
Application

Project Name: Cameron Hall and Courtyard

Cameron Summer House

- WE Project No. 2017-062
- November 28, 2017

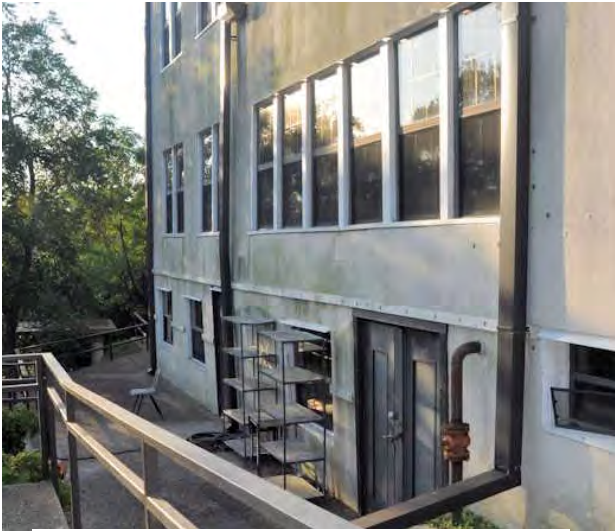
Figure 8

Upon the initial site observation for this report, made on September 18, the bulge on the rear wall was evident from the exterior. Gutters were displaced at joints nearest the first-floor level (see Figure 8), and plumb measurements indicated an outward lean of up to 3.6° near the center of the wall length. From the interior, the floor noticeably sloped downward toward the wall¹⁰ and the settlement was reflected in the exhibit panels along the rear walls (see Figure 9). The Art Center staff assisted in removing the art from several of the panels and moving one panel to allow direct access to the rear wall itself.

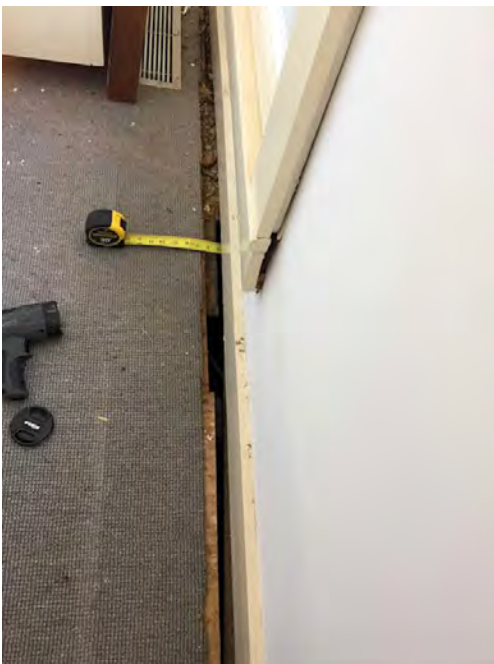
Figure 10

Inspection along the base of the wall revealed that the problem was not limited to a bulge in the exterior stucco finish. A gap of two-to-three inches was observed in the first-floor decking (see Figure 10), and it appeared that the load-bearing wall framing itself had separated from the main floor system. Subsequent borescope images revealed that the gap extended to the basement level below, although hidden by suspended HVAC ductwork at that level. The edges of the floor decking on each side of the gap were observed to be smooth, straight, and even (see Figure 11) and appeared to have been saw-cut at some time in the past.

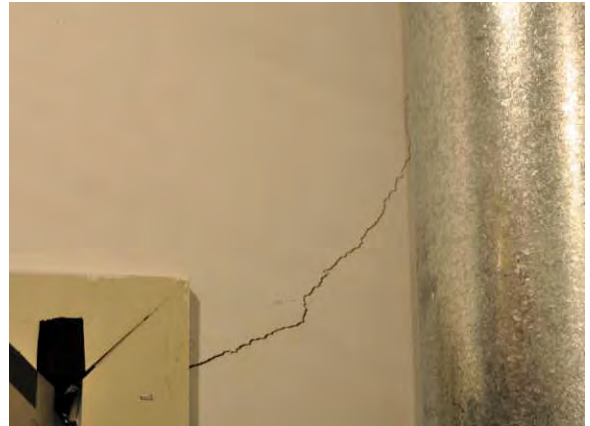
Figure 17

The floor settlement was noticeable during the September 18 site observation; predominantly a downward slope toward the wall separating the men's restroom from the counter/sink area, and in the darkroom. The door to the darkroom was difficult to open, and significant settlement cracks were observed in the darkroom itself (see Figure 17). Results of the floor elevation study indicated the lowest floor elevation readings near the northwest corner of the restroom, along the wall common to the darkroom.

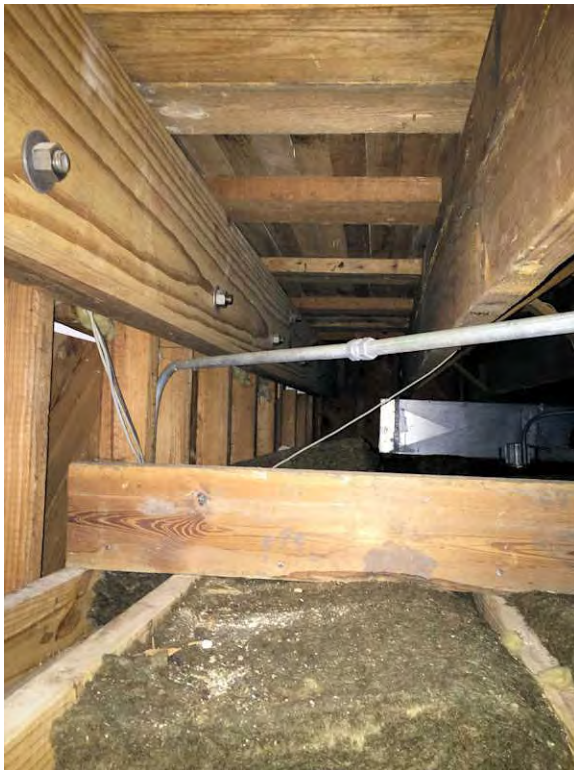
Figure 18

A double 2x wood beam with a steel flitch-plate was observed running east-to-west and along the wall separating the mechanical room from the gallery to the north (see Figure 18). No visible support was observed at either end of the beam. It appeared that the beam may have been nailed or possibly lag screwed to the adjacent wall studs or an existing floor joist, however confirmation of such was not possible. The purpose of the beam is also unknown. It did not appear on the Waco Creative Art Center renovation plans¹⁴, and without end support the need for the steel flitch-plate is uncertain. A possibility is that the beam was originally intended for another location, and repurposed here at a later date.

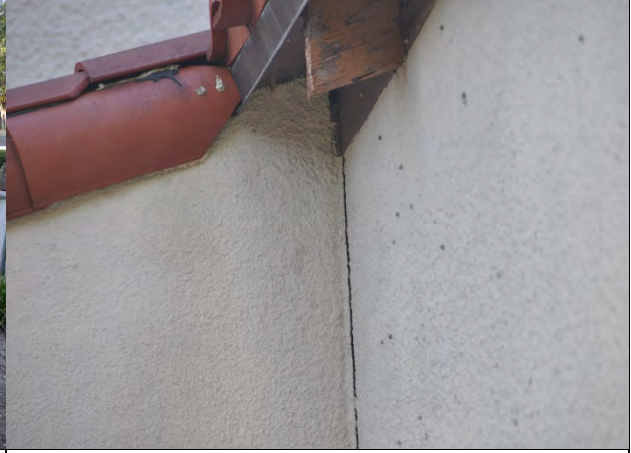
Photo 8

24. A landscaped courtyard with an underground drainage system is located on the west side of the building. (Photo 7)
 25. Separation of the exterior stucco finishes was observed at an interior corner near the northwest side of the building. (Photo 8)

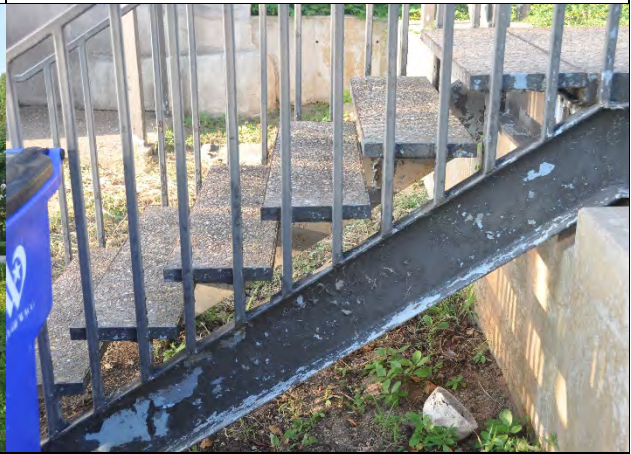
Photo 10

26. A steel exit stair system is located at the northwest corner of the building. (Photo 9) The stair system was observed to be in need of repainting (Photo 10) and repair. (Photo 11)

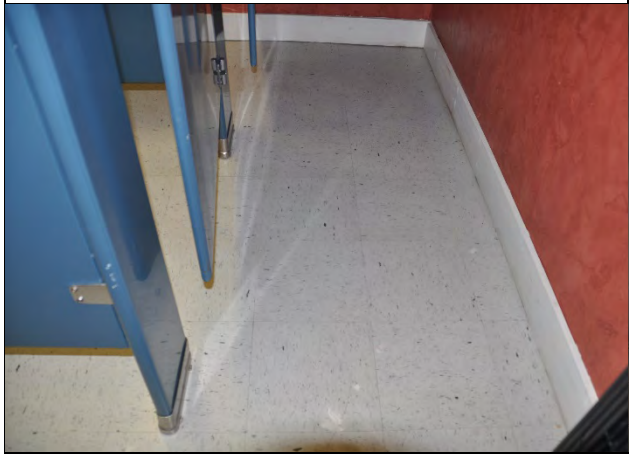
Photo 63

70. A noticeable floor slope was observed in the women's restroom, from south to north. *(Photo 63)*
 71. Window trim at windows on the east wall were pulling away from the wall surface. *(Photo 64)*

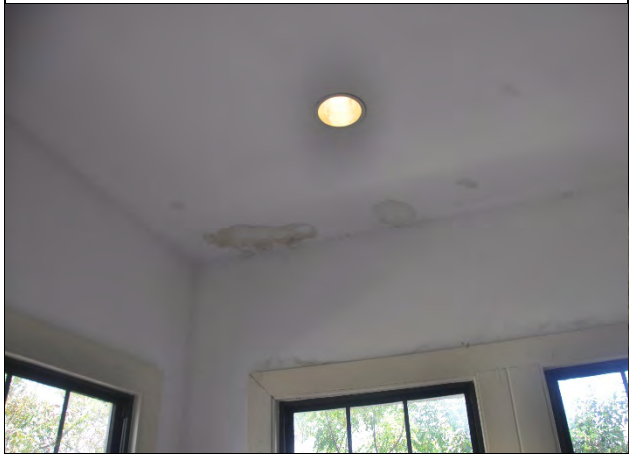
Photo 65

72. Moisture damage was observed on the ceiling in the far northeast corner. *(Photo 65)*
 73. Moisture damage was observed on the floor of the mechanical closet. *(Photo 66)*

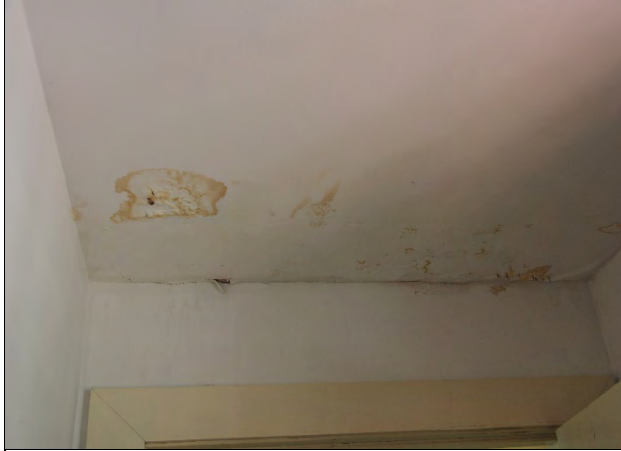
Photo 67

74. Moisture damage was observed over the door to the west addition. *(Photo 67)*
 75. An attic hatch is located on the west side of the reception desk area. *(Photo 68)*

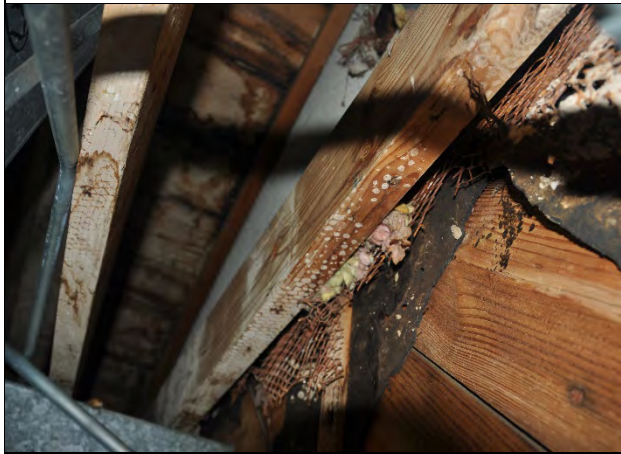
Photo 69

76. The original exterior finish composition can be seen through the attic hatch. *(Photo 69)* *(Diagonal wood sheathing, felt paper, wood lathing strips, metal lath, stucco.)*

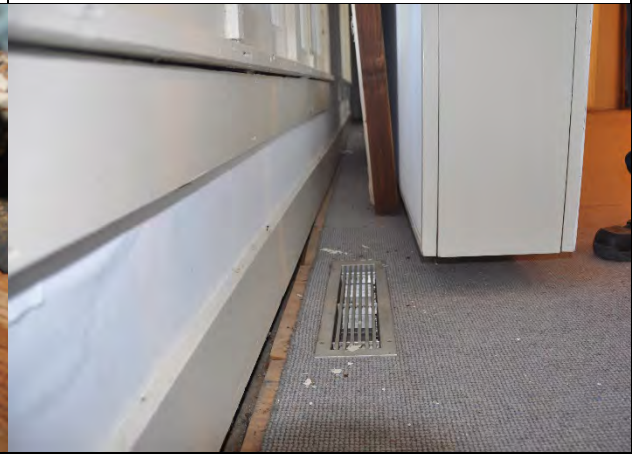
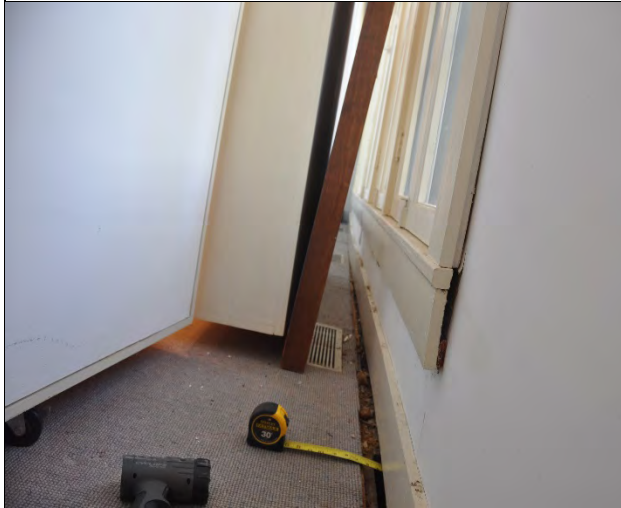
77. Behind the portable display walls, the north wall was found to be separating from the first-floor framing. *(Photos 70, 71)*

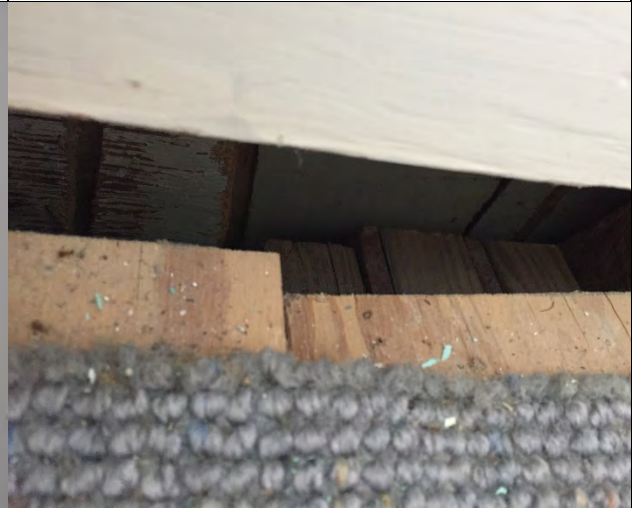
Photo 72

78. A steel flitch-plated beam could be seen in the gap, along with saw cuts in exterior rim joists. *(Photo 72)*
 79. Borescope photographs indicated the nails used to secure the 2x4 banding along the rear wall had pulled away from the wood framing behind. *(Photo 73)*

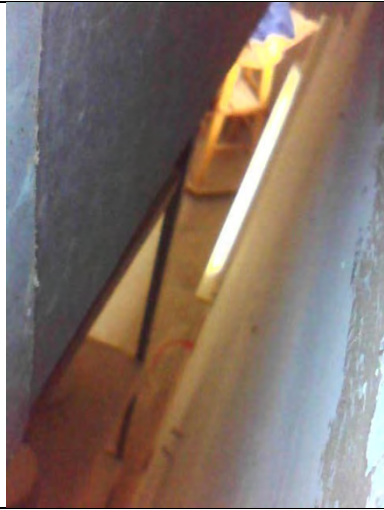
Photo 74

80. Borescope photograph revealed the basement level below can be seen through the separation along the north wall. *(Photo 74)*
 81. Separation of the wall near the middle was measured at 2-5/8 inches on 10-2-17. *(Photo 75)*

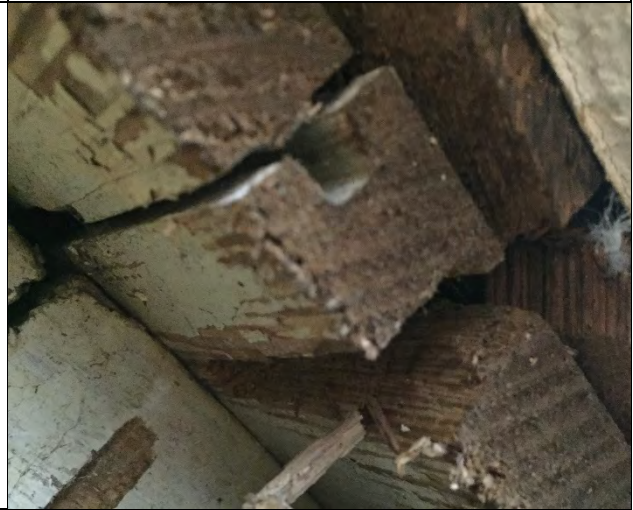
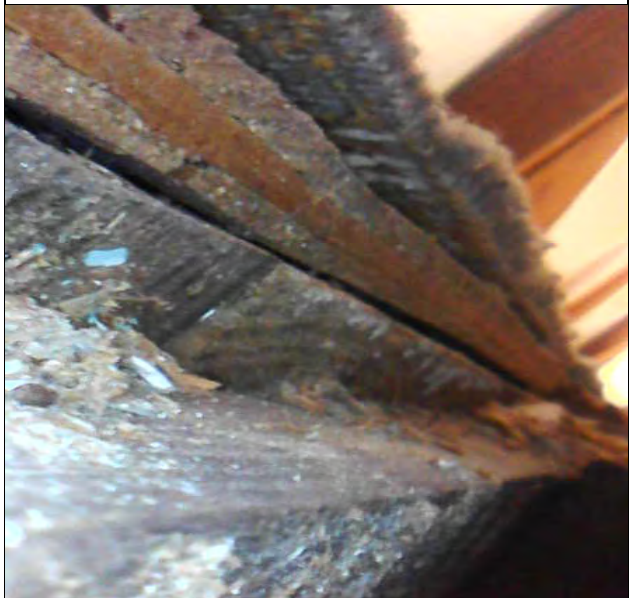
82. Edges of the original tongue-and-groove flooring, as well as the plywood overlay, were smooth and even and appeared to have been saw-cut at some point in the past. *(Photos 76, 77)*

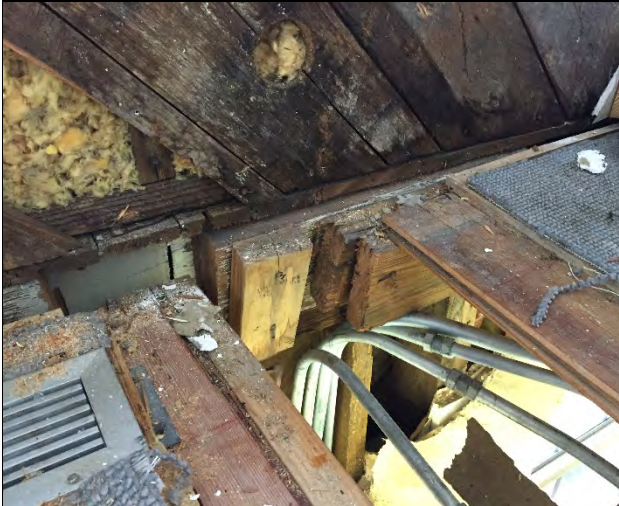
Photo 78

83. Significant damage to the rear wall framing was observed near electrical conduit installations. *(Photo 78)*
 84. Wall framing was removed on the first-floor level to reveal that portions of the upper wall have no remaining support below. *(Photos 79, 80)*

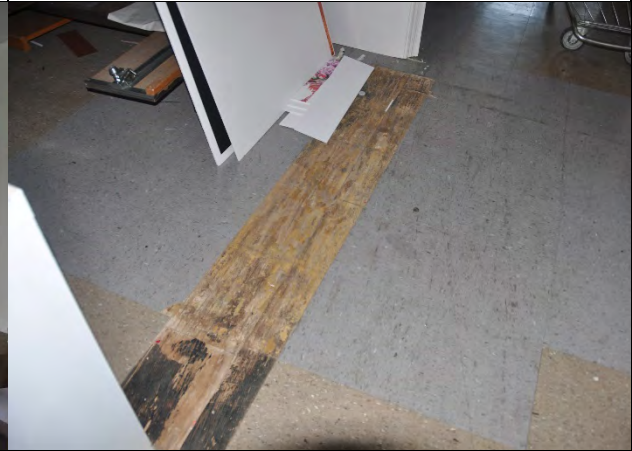
Photo 81

- Second-Floor Observations - Information noted during the inspection of the second-floor level included:
 85. The floor and ceiling of the second floor appear to slope back toward the restroom wall. *(Photo 81)*

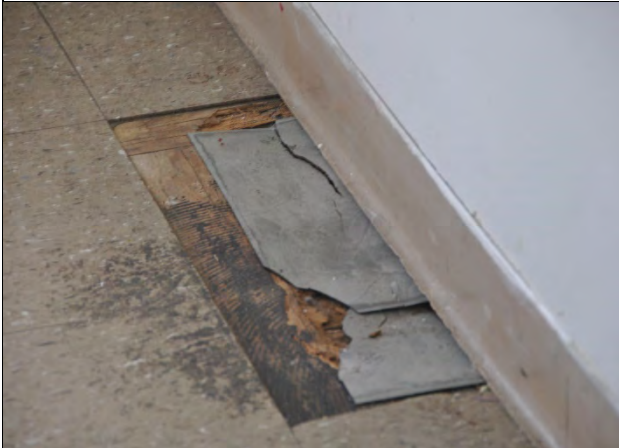
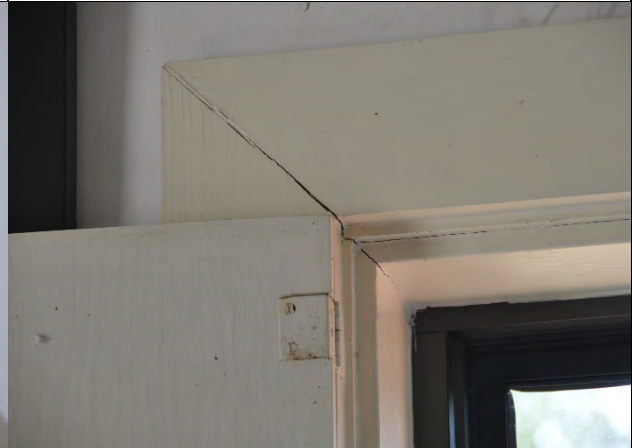
86. Vinyl floor tiles have popped loose from the wood floor decking at numerous locations. *(Photos 82, 83)*
 87. Minor cracking around door and window frames was observed at several locations on the second-floor level. *(Photo 84)*

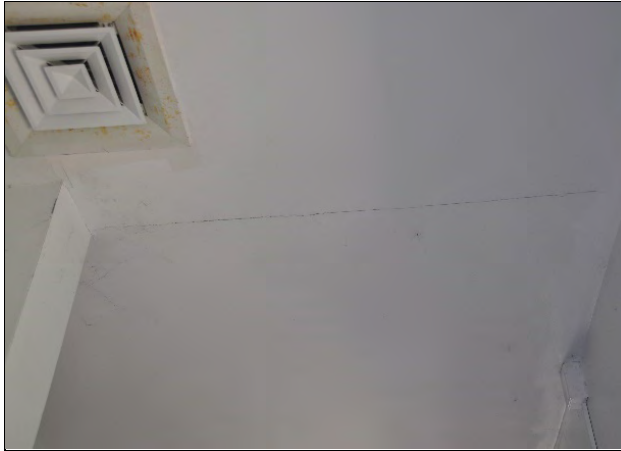
Photo 85

88. Cracks were observed in the sheetrock ceiling at the northwest corner of the second floor. *(Photo 85)*
 89. Cracks and separation of the wall and ceiling were observed at the wall to the men's restroom. *(Photo 86)*

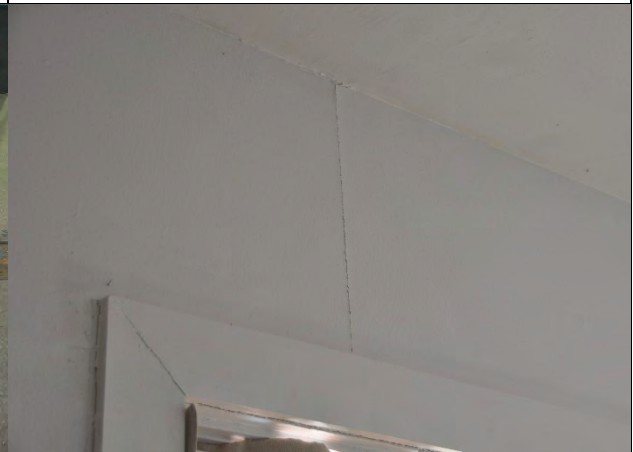
Photo 88

90. A wooden threshold separates the east wing addition from the main building. *(Photo 87)*
 91. Cracks in the sheetrock walls were observed on the south wall. *(Photo 88)*

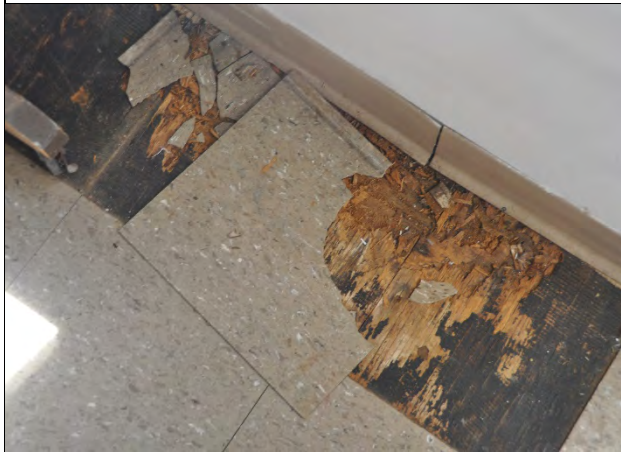
Photo 89

92. Damage to the wood floor decking was observed near the south wall. *(Photo 89)*
 93. Moisture damage was observed at the ceiling above the south gallery area. *(Photo 90)*

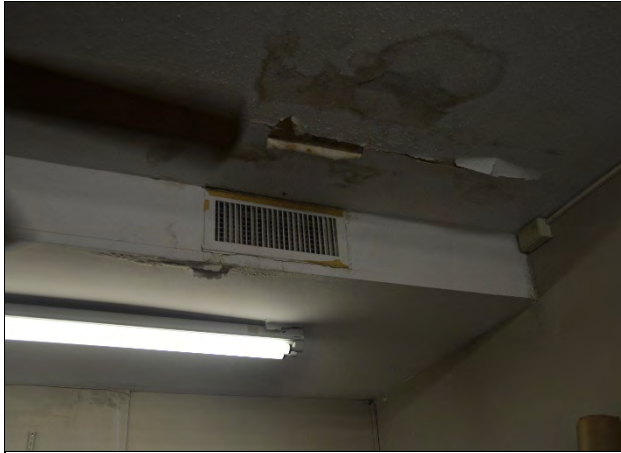
Photo 91

94. Moisture damage was observed at the ceiling above the southeast storage room. *(Photo 91)*
 95. Signs of active water leaks were observed in the second-floor storage room. *(Photo 92)*

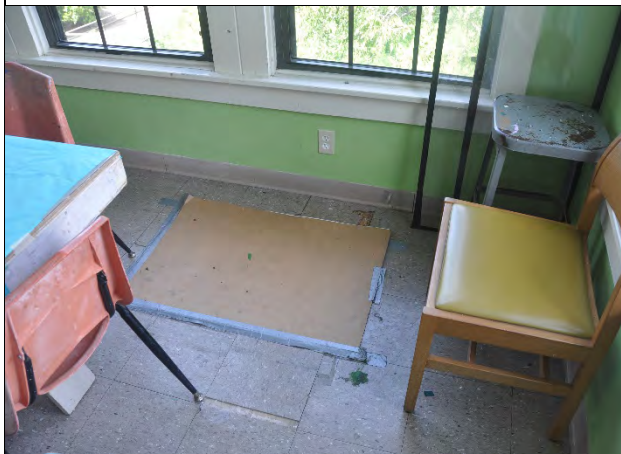
Photo 93

96. A large area of separated floor tile was observed in the northeast corner of the building. *(Photo 93)*
 97. A large crack is present in the wall above the door to the darkroom. *(Photo 94)*

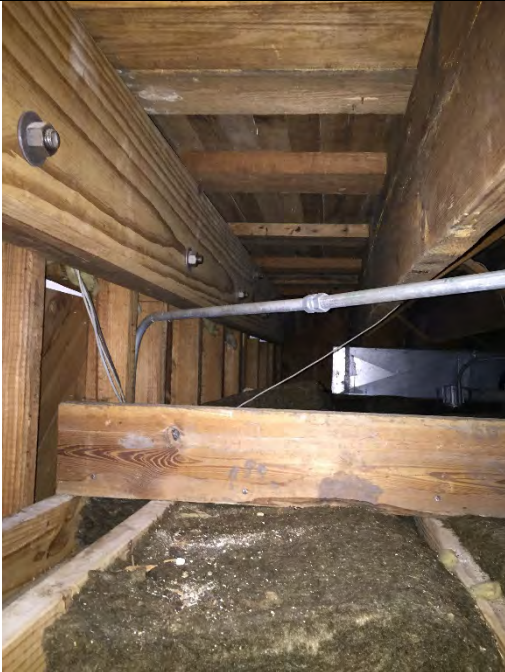
Photo 96

99. Second-floor framing was observed through a cut-out in the first-floor mechanical room. The first-floor ceiling is approximately 28 inches below the bottom of the second-floor deck at that point. *(Photo 96)*

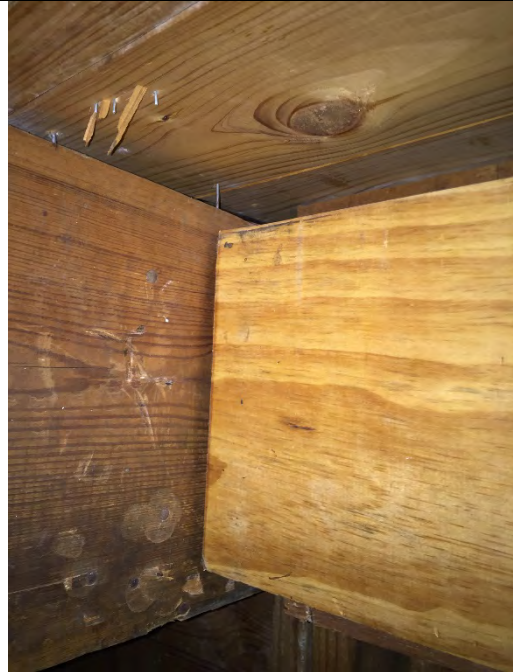
Photo 97

100. A large steel flitch-plated beam was observed adjacent to the north wall between the mechanical room and the gallery. *(Photo 97)* No support was visible at either end of the beam. It appeared it may have been nailed or lagged to the adjacent wall studs.

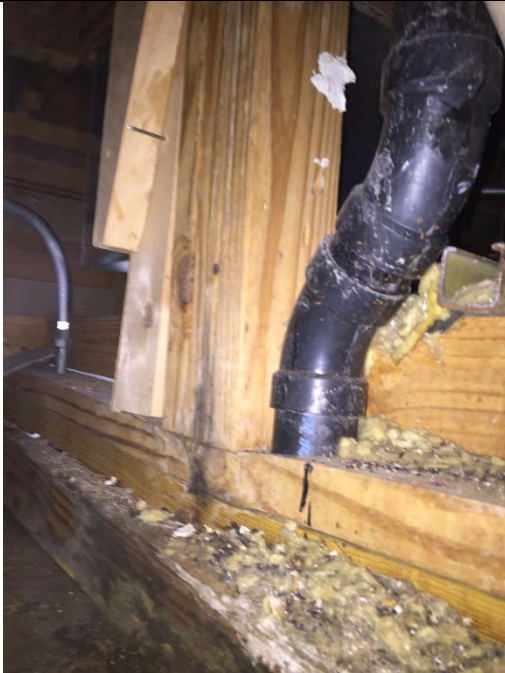
Photo 98

101. The west end of the beam was unattached to a large beam running north-south. *(Photo 98)*
102. The north-south beam was found to be supported at the wall separating the men's and women's restrooms by 2x4 studs set on top of a double top plate. *(Photo 99)* (A plumbing pipe immediately to the east of the supports effectively cut the top plate in half at this point.)

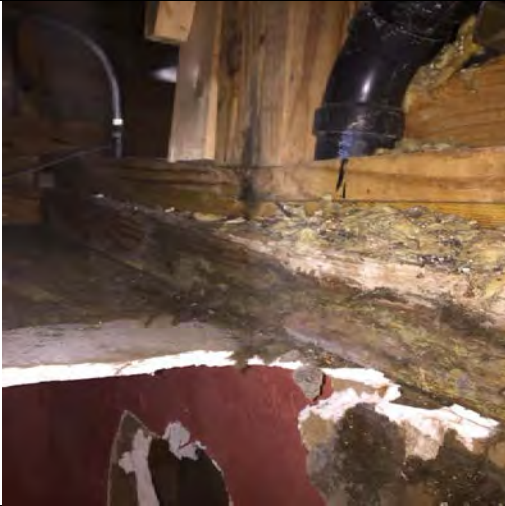
Photo 100

103. The top plate had deflected significantly. *(Photo 100)*
104. The wall finishes directly below the 2x supports was removed to reveal no structural support below the compromised plates. *(Photo 101)*

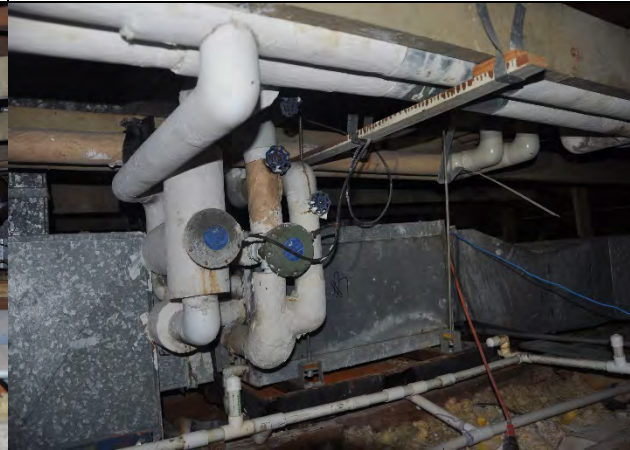
109. Abandoned HVAC equipment was observed in the attic. *(Photos 103, 104)*

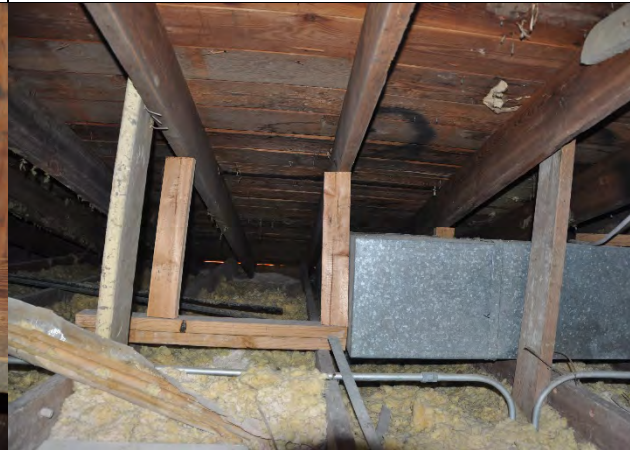
Photo 105

110. Roof decking is original lumber, and appeared to be in good condition where observed. *(Photo 105)*

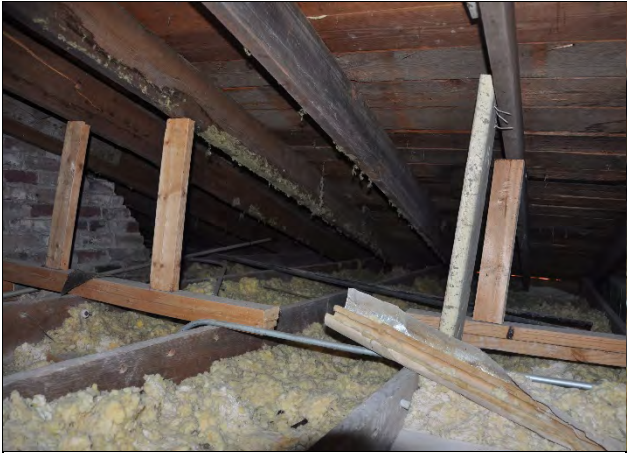
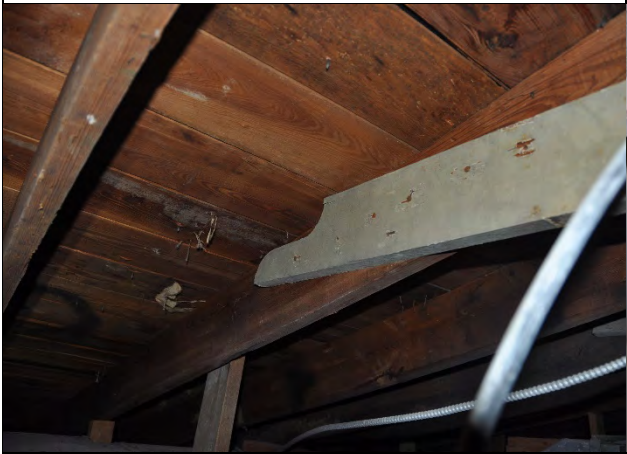
111. Additional bracing has been installed under the roof rafters in much of the observed attic space. *(Photos 106, 107, 108)*

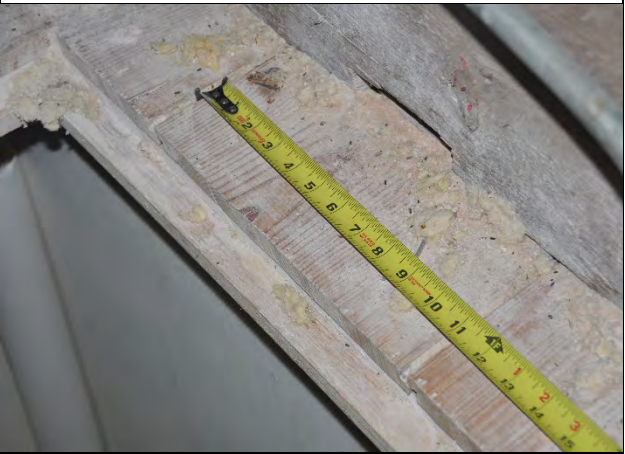
Photo 109

112. It appeared that some of the framing members in the attic space had been salvaged from other projects. *(Photo 109)* Note the green paint and the trellised end-cut. *(Also note that similar green painted wood was observed in other locations, such as the lower floor walls. It is unclear if the wood was a part of the original construction, or if it was used at a later date for repairs.)*

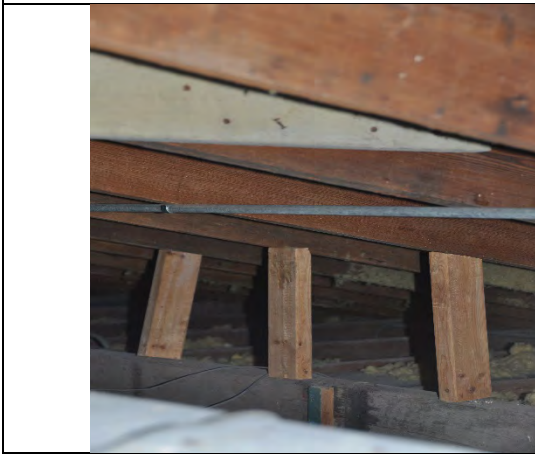
Photo 110

113. There is a wood plank ceiling installed directly to the ceiling joists, with a sheetrock ceiling below. *(Photo 110)*

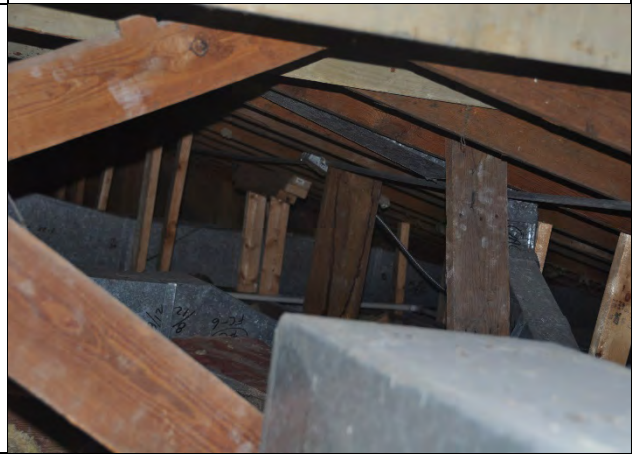
114. Additional added bracing was observed. *(Photos 111, 112)*

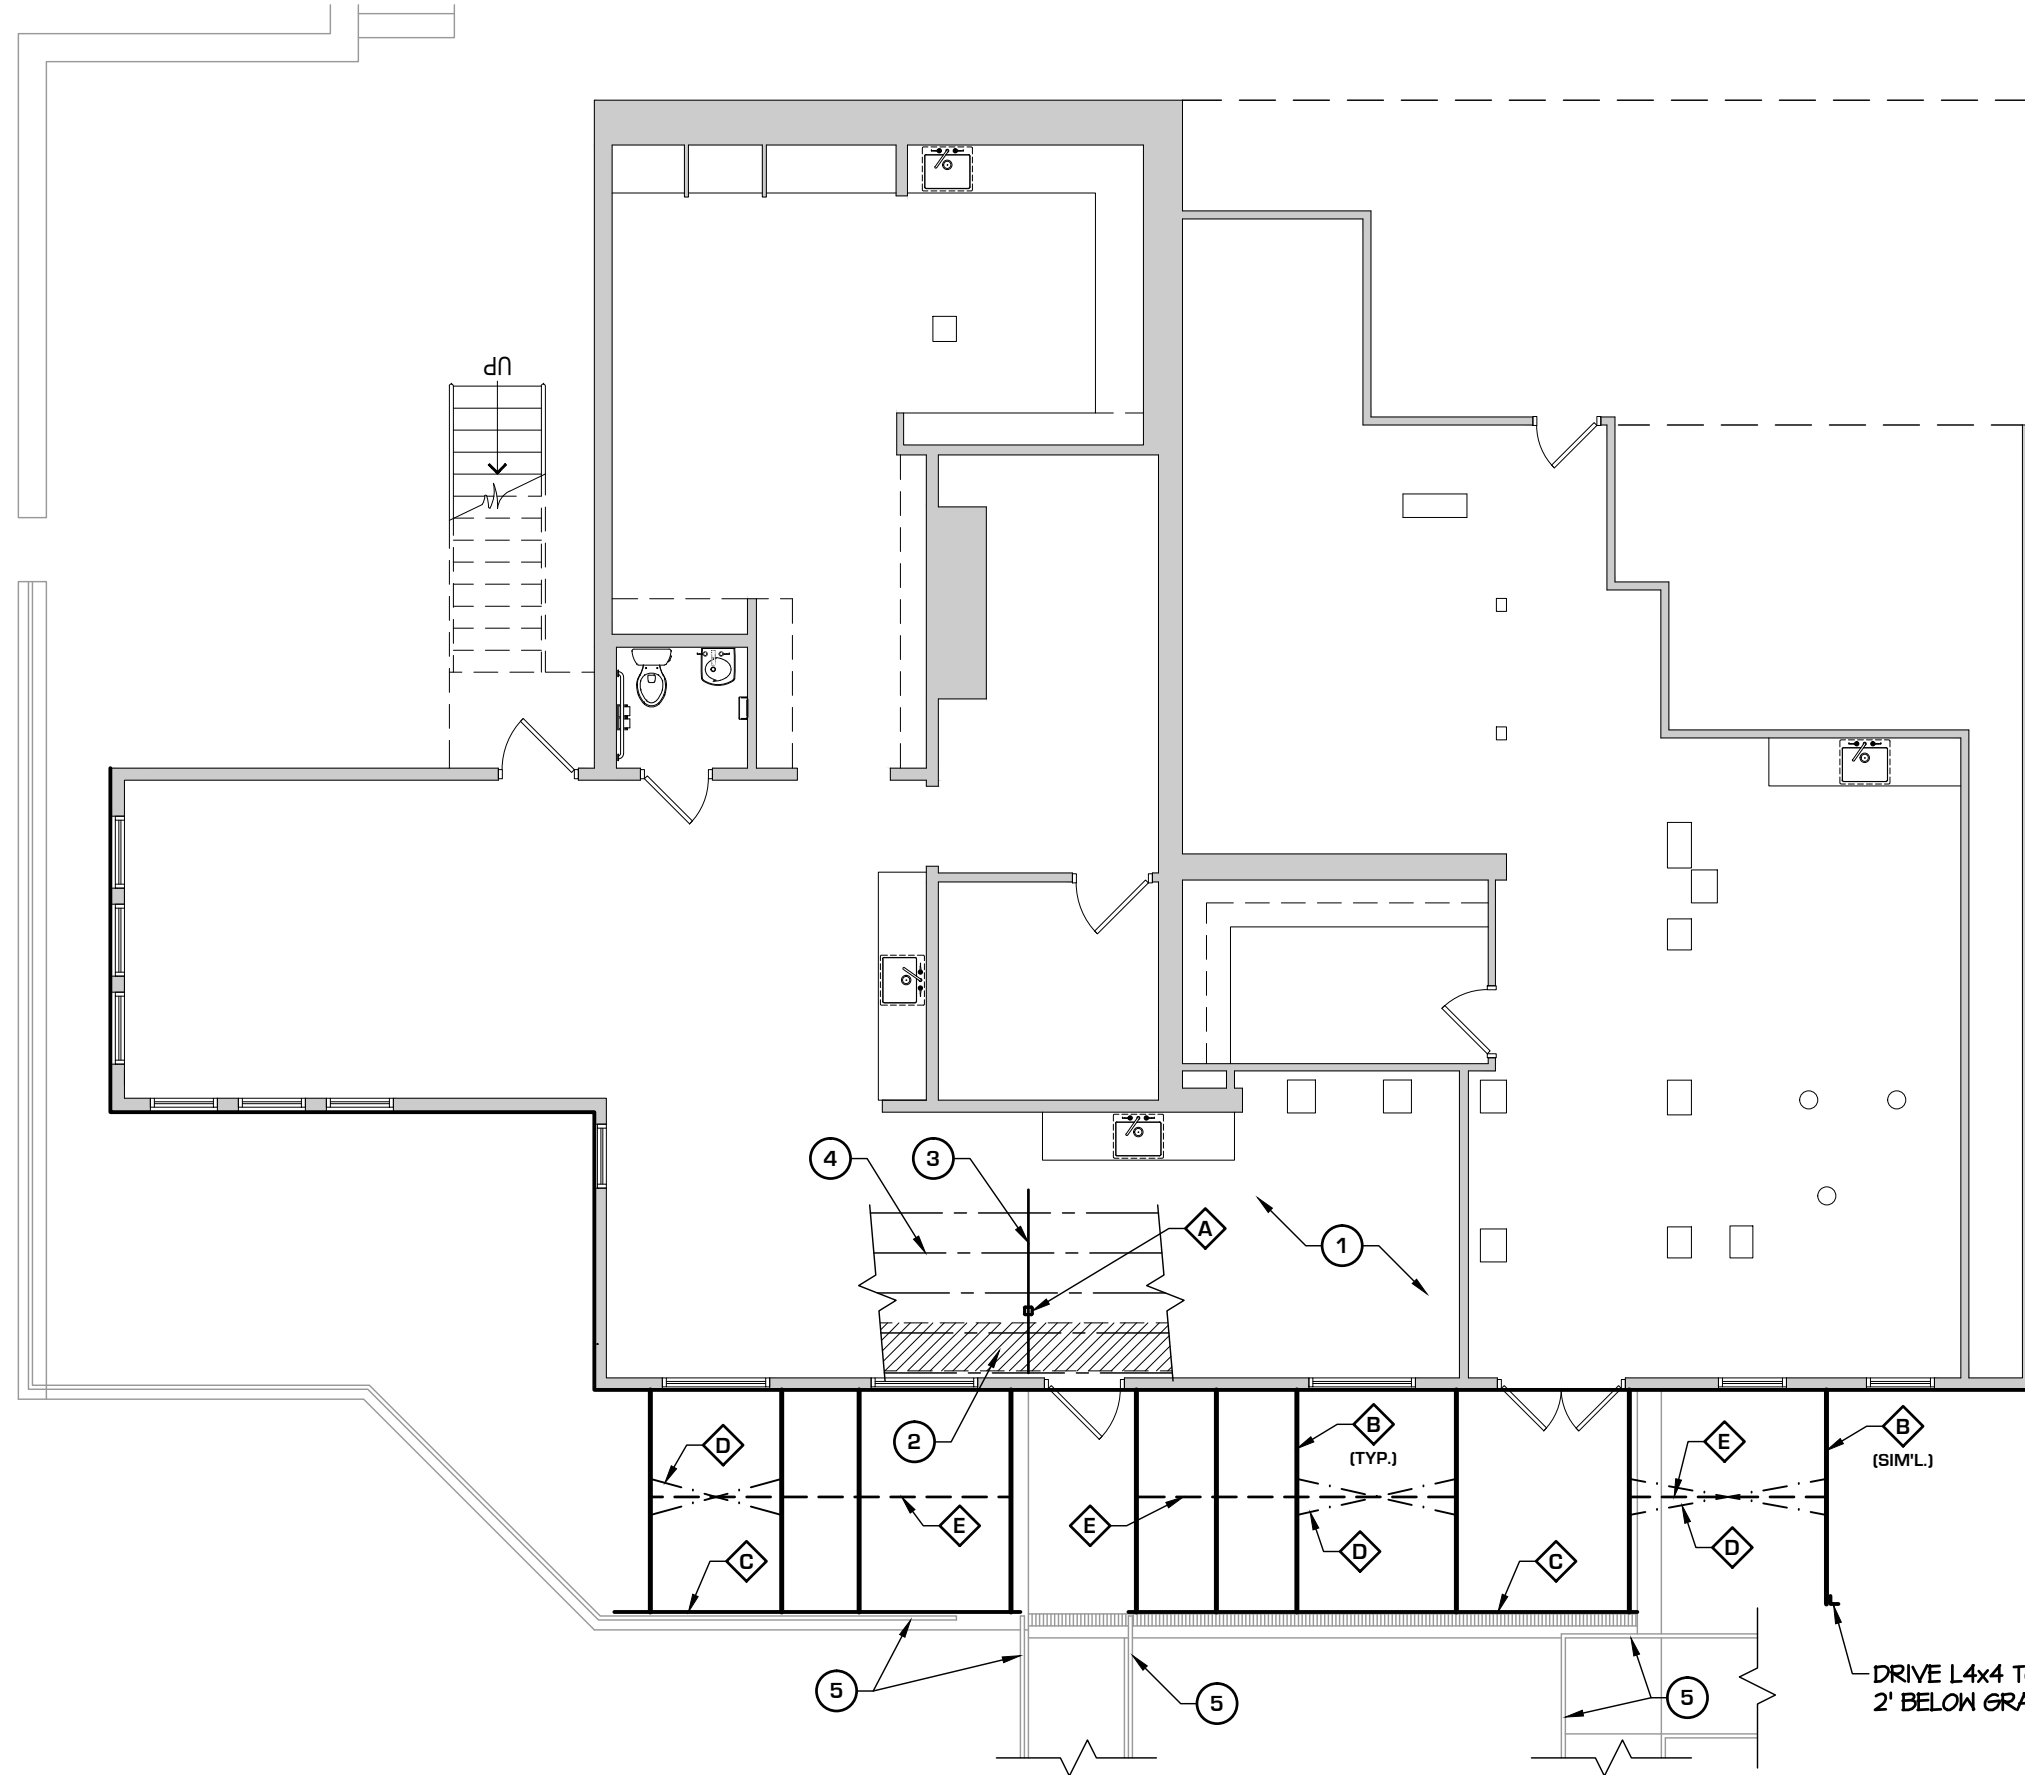
1 **BASEMENT FLOOR - TEMPORARY SHORING PLAN**
 SCALE: 1/8" = 1'-0"±

- EXIST. CONSTRUCTION**
- ① EXISTING BASEMENT AREA.
 - ② EXISTING HVAC DUCTWORK ABOVE.
 - ③ EXISTING 3-PLY WOOD BEAM WITH STEEL FLITCH PLATES - TO REMAIN. PROVIDE TEMPORARY 4x4 STEEL SHORING POST AS NOTED.
 - ④ EXISTING 2x FIRST FLOOR FRAMING. (RUNS PARALLEL TO THE EXTERIOR WALL.)
 - ⑤ EXISTING STEEL TUBE GUARDRAIL.
