City of Waco
Tax Increment Financing (TIF)
Application

Cameron Hall and Courtyard

Cameron Summer House

- WE Project No. 2017-062
- November 28, 2017

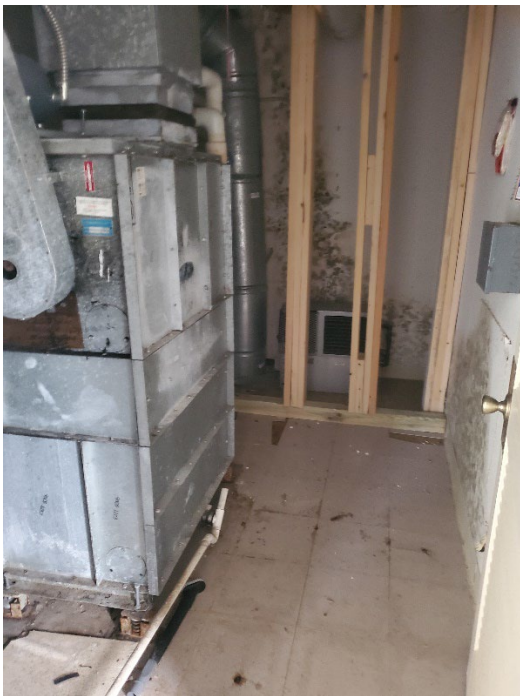
Figure 10. Cameron House Interior (HVAC Unit)

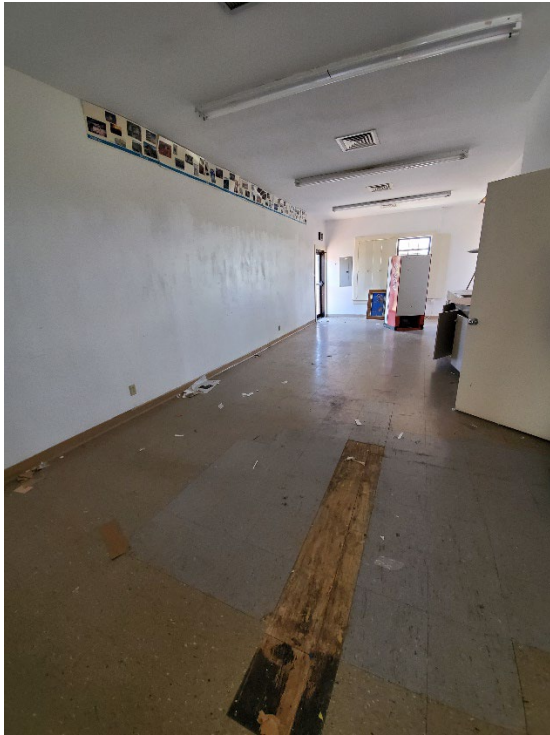
Figure 11. Cameron House Interior (2nd floor)

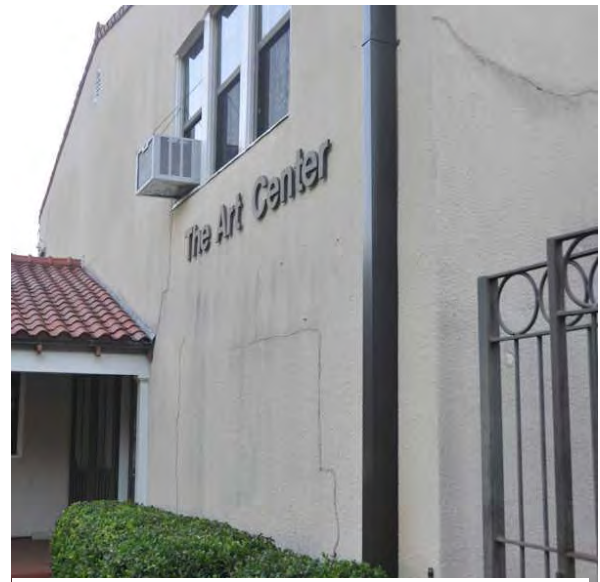
Figure 6

Some of the cracks observed near the rear wall (*see Figure 5*) can be attributed with certainty to the structural issues discovered there. Others, such as the diagonal cracks observed near the main entrance (*see Figure 6*), may be the result of foundation settlement. Results of the basement level floor elevations indicated potential settlement consistent with the orientation

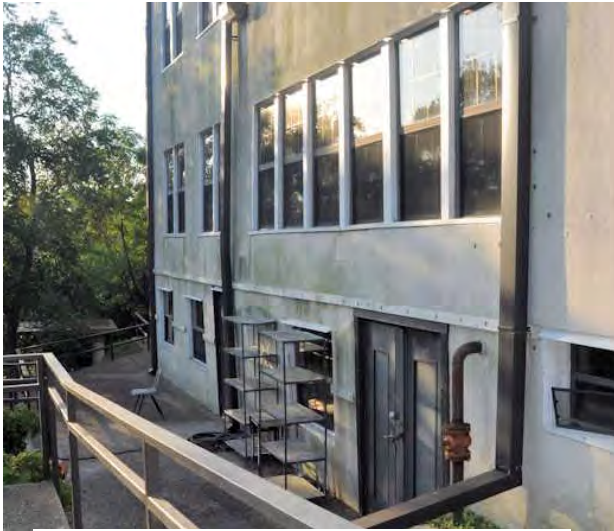
Figure 8

Upon the initial site observation for this report, made on September 18, the bulge on the rear wall was evident from the exterior. Gutters were displaced at joints nearest the first-floor level (see Figure 8), and plumb measurements indicated an outward lean of up to 3.6° near the center of the wall length. From the interior, the floor noticeably sloped downward toward the wall¹⁰ and the settlement was reflected in the exhibit panels along the rear walls (see Figure 9). The Art Center staff assisted in removing the art from several of the panels and moving one panel to allow direct access to the rear wall itself.

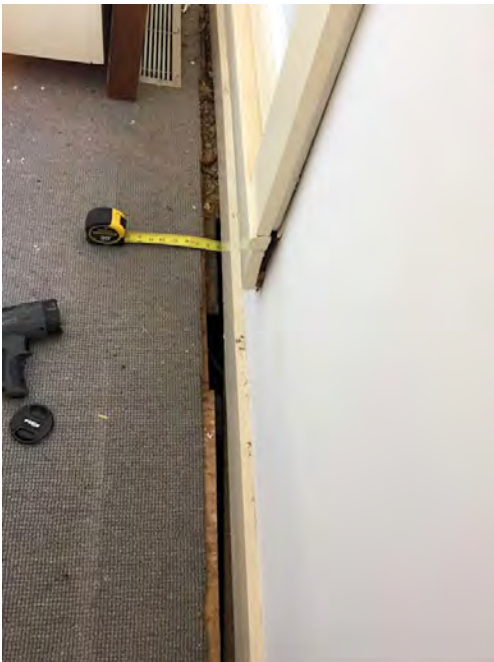
Figure 10

Inspection along the base of the wall revealed that the problem was not limited to a bulge in the exterior stucco finish. A gap of two-to-three inches was observed in the first-floor decking (see Figure 10), and it appeared that the load-bearing wall framing itself had separated from the main floor system. Subsequent borescope images revealed that the gap extended to the basement level below, although hidden by suspended HVAC ductwork at that level. The edges of the floor decking on each side of the gap were observed to be smooth, straight, and even (see Figure 11) and appeared to have been saw-cut at some time in the past.

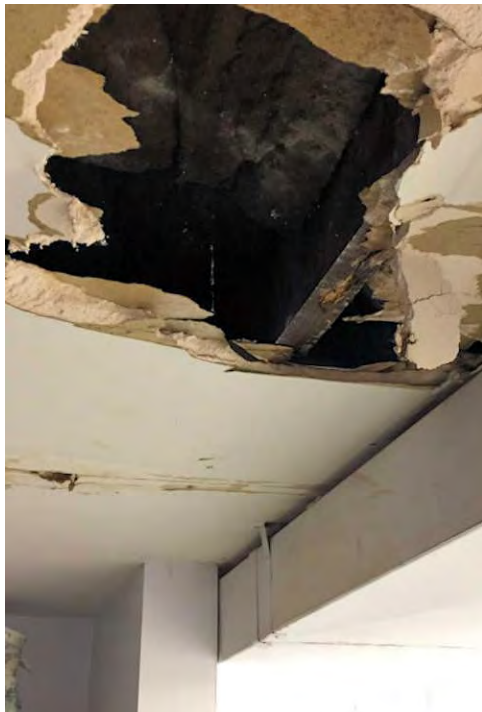
Figure 20

Following the load down to the lower levels, the supporting wall is located above an open area on the basement level. The 1974 renovation plans indicated that a new steel flitch-plated beam was to be installed below the wall. Partial removal of ceiling finishes in the basement revealed that no such beam was installed at the location (see Figure 20).

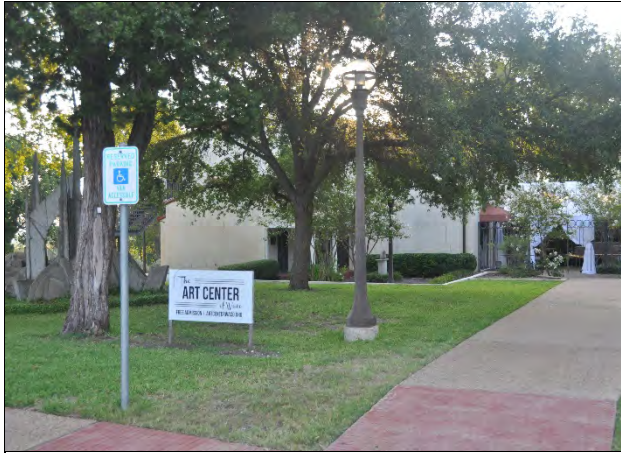
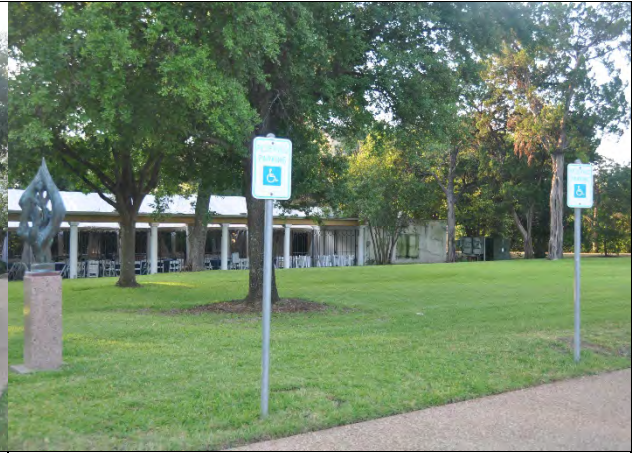
- Exterior Observations - Information noted during the visual inspection of the exterior of the house included:
 21. The house is located in a wooded area, with the terrain from the south and west gently sloping toward the house. (*Photos 1, 2*) The terrain on the north and east sides of the house is a limestone rock outcropping which slopes sharply down approximately 100 feet to the Bosque River basin. (*Photo 3*)

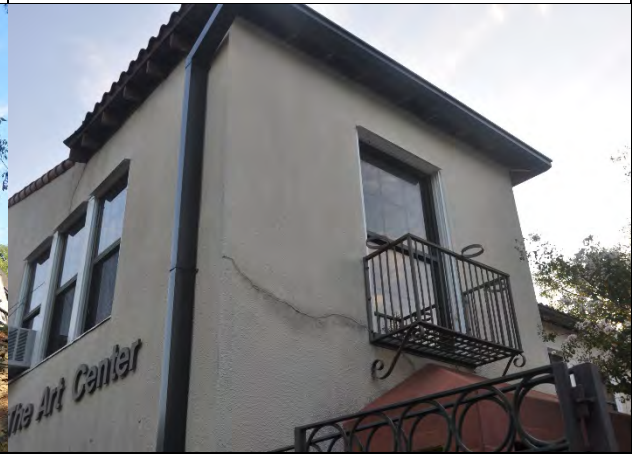
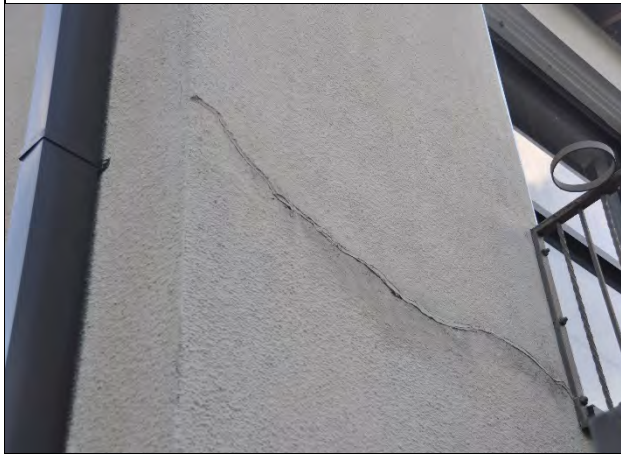
22. Cracks were observed on the south side of the building, near the southwest corner. The cracks had been caulked. (*Photos 4, 5*)
 23. Similar cracks and repairs were observed on the west side of the building. (*Photo 6*)

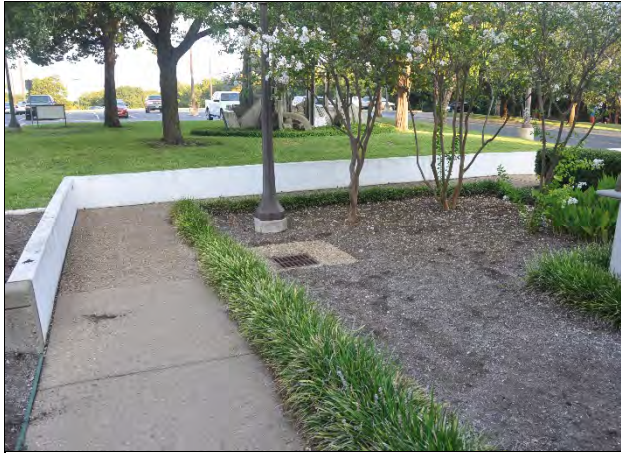
Photo 7

24. A landscaped courtyard with an underground drainage system is located on the west side of the building. (*Photo 7*)
 25. Separation of the exterior stucco finishes was observed at an interior corner near the northwest side of the building. (*Photo 8*)

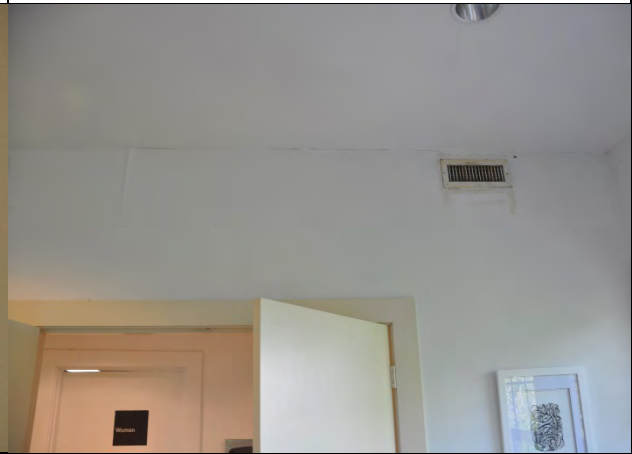
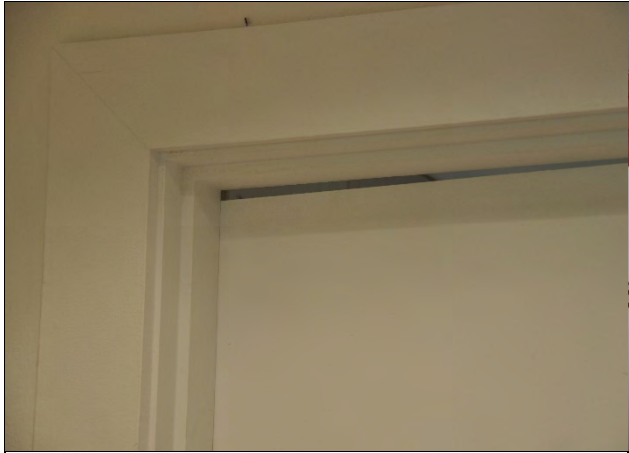
68. Minor cracks in the sheetrock walls were observed at various locations throughout the first-floor level. *(Photos 59, 60)*
69. The door to the **women's restroom** was observed to be significantly out-of-square with the frame. *(Photos 61, 62)*

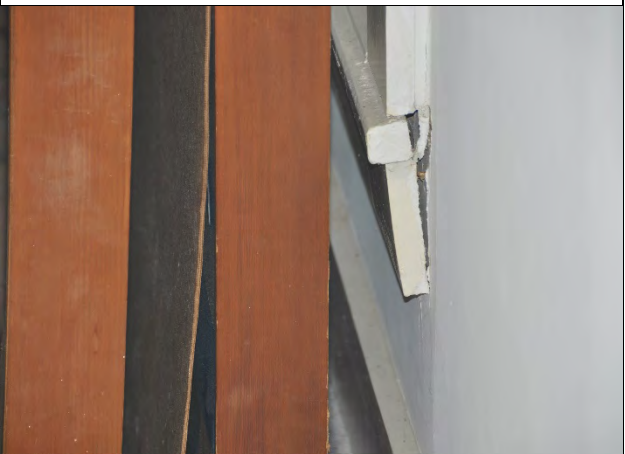
Photo 63

70. A noticeable floor slope was observed in the women's restroom, from south to north. *(Photo 63)*
71. Window trim at windows on the east wall were pulling away from the wall surface. *(Photo 64)*

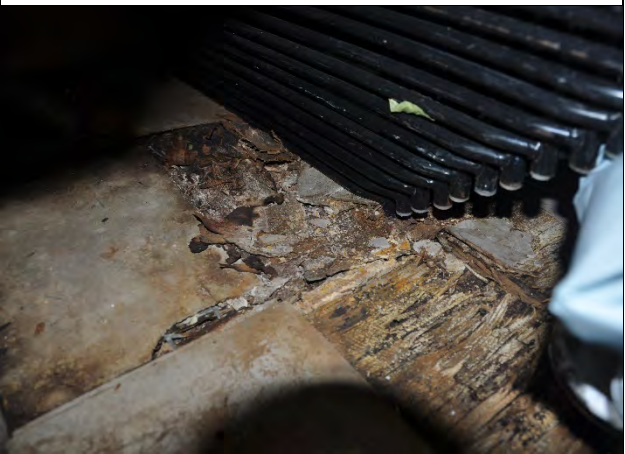
Photo 65

72. Moisture damage was observed on the ceiling in the far northeast corner. *(Photo 65)*
73. Moisture damage was observed on the floor of the mechanical closet. *(Photo 66)*

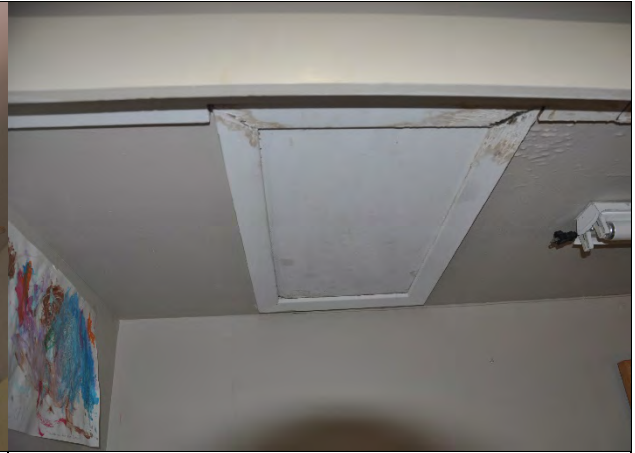
Photo 67

74. Moisture damage was observed over the door to the west addition. *(Photo 67)*
75. An attic hatch is located on the west side of the reception desk area. *(Photo 68)*

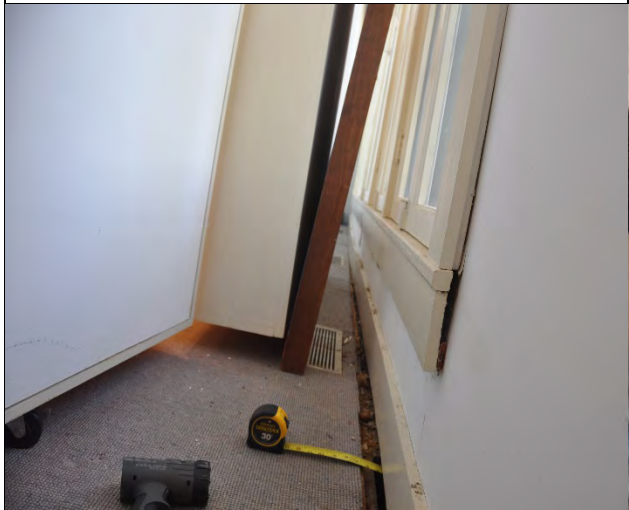
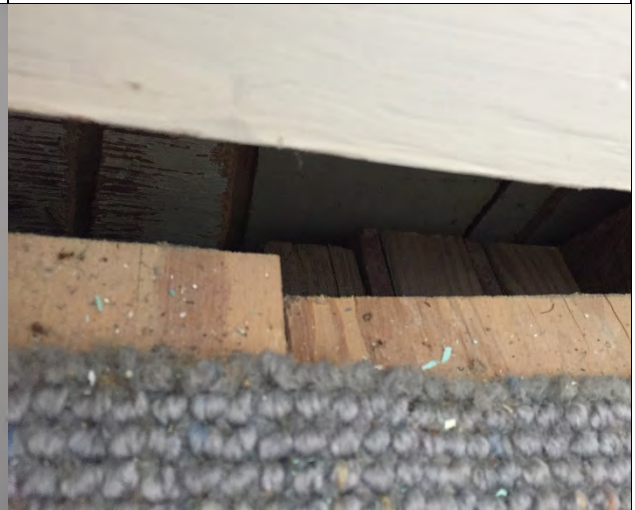
77. Behind the portable display walls, the north wall was found to be separating from the first-floor framing. *(Photos 70, 71)*

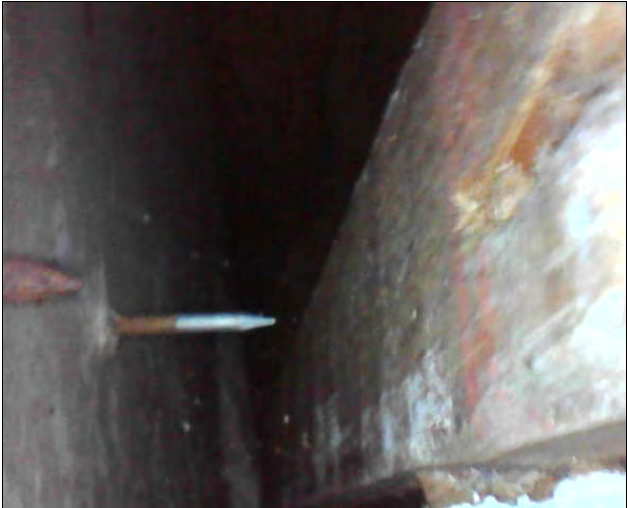
Photo 72

78. A steel flitch-plated beam could be seen in the gap, along with saw cuts in exterior rim joists. *(Photo 72)*
79. Borescope photographs indicated the nails used to secure the 2x4 banding along the rear wall had pulled away from the wood framing behind. *(Photo 73)*

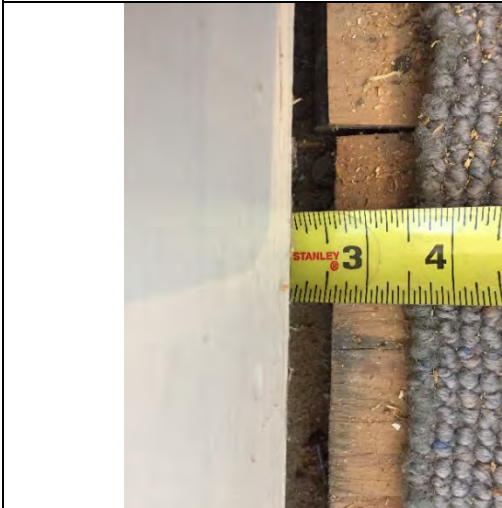
Photo 74

80. Borescope photograph revealed the basement level below can be seen through the separation along the north wall. *(Photo 74)*
81. Separation of the wall near the middle was measured at 2-5/8 inches on 10-2-17. *(Photo 75)*

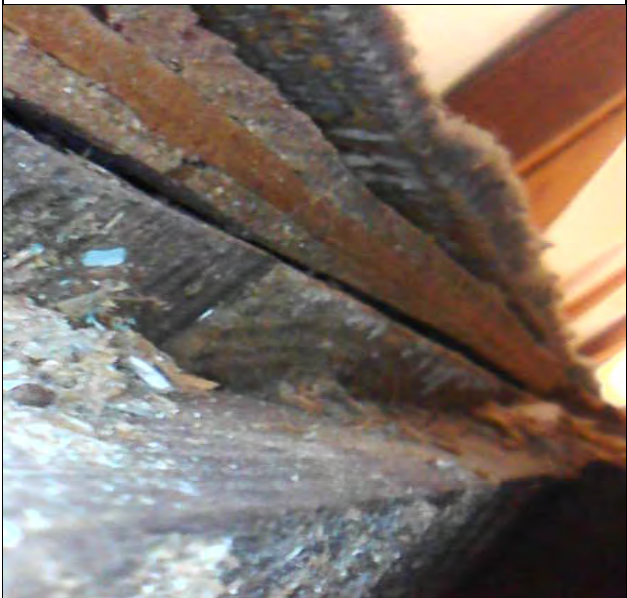
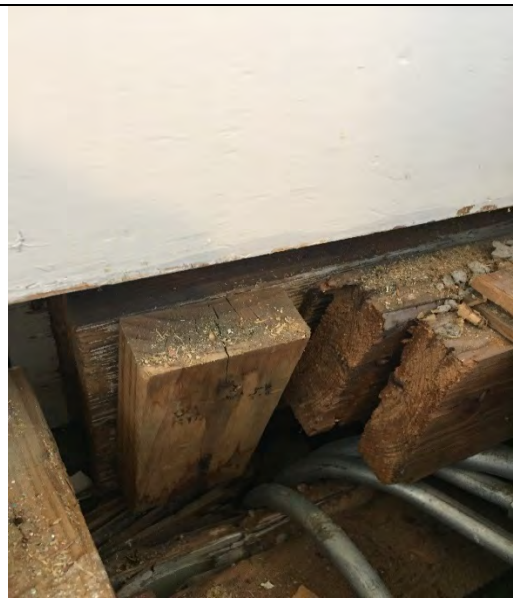
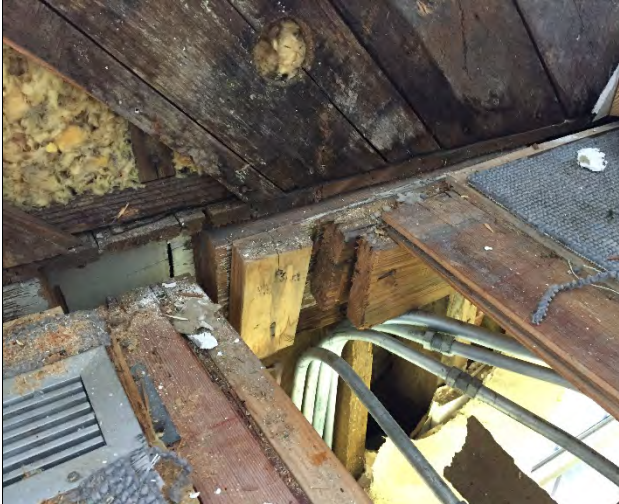
82. Edges of the original tongue-and-groove flooring, as well as the plywood overlay, were smooth and even and appeared to have been saw-cut at some point in the past. *(Photos 76, 77)*

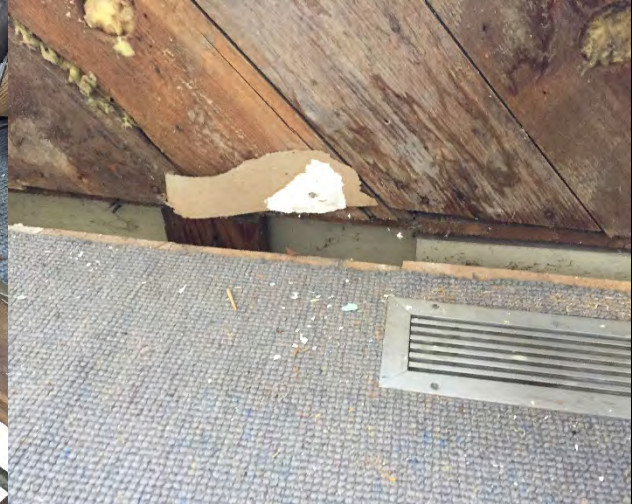
Photo 78

83. Significant damage to the rear wall framing was observed near electrical conduit installations. *(Photo 78)*
84. Wall framing was removed on the first-floor level to reveal that portions of the upper wall have no remaining support below. *(Photos 79, 80)*

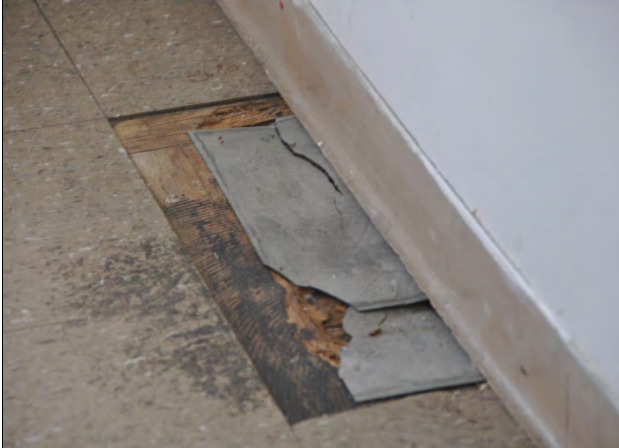
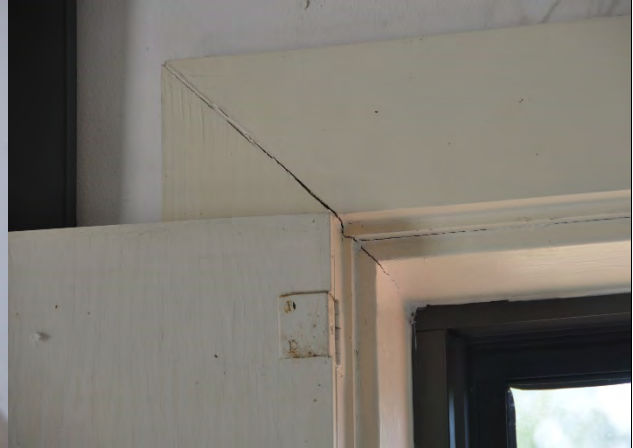
86. Vinyl floor tiles have popped loose from the wood floor decking at numerous locations. *(Photos 82, 83)*

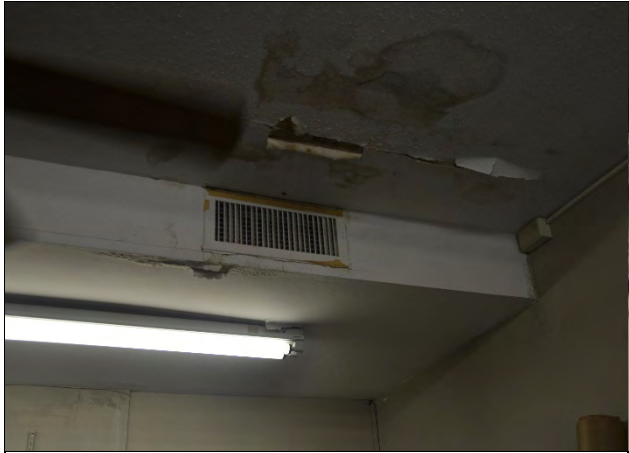
Photo 90

93. Moisture damage was observed at the ceiling above the south gallery area. *(Photo 90)*

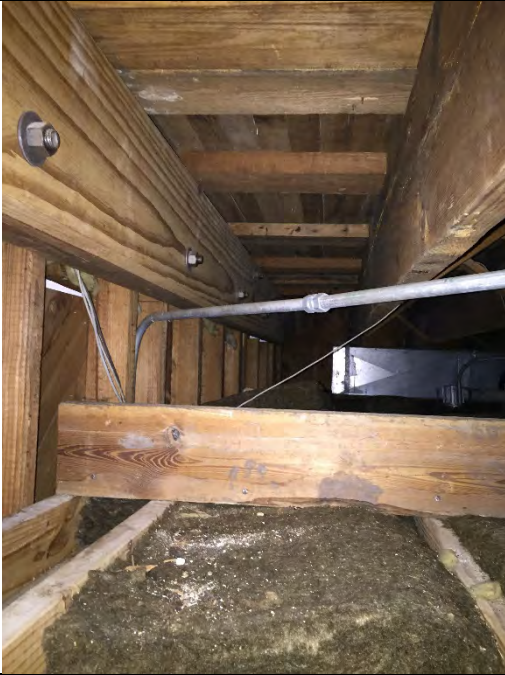
Photo 96

99. Second-floor framing was observed through a cut-out in the first-floor mechanical room. The first-floor ceiling is approximately 28 inches below the bottom of the second-floor deck at that point. *(Photo 96)*

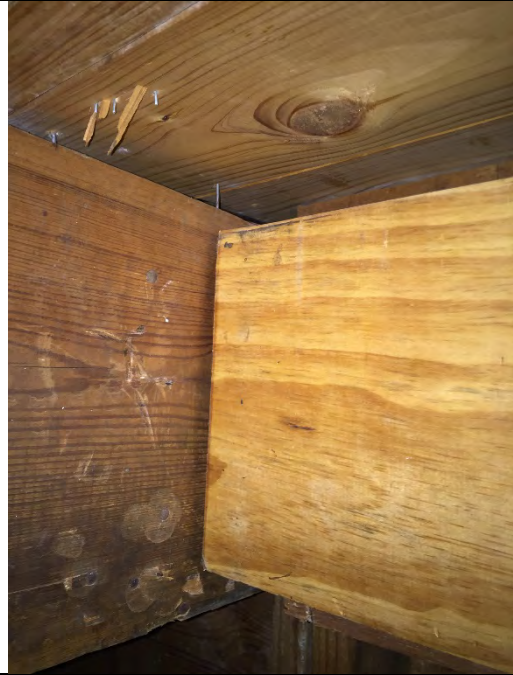
Photo 97

100. A large steel flitch-plated beam was observed adjacent to the north wall between the mechanical room and the gallery. *(Photo 97)* No support was visible at either end of the beam. It appeared it may have been nailed or lagged to the adjacent wall studs.

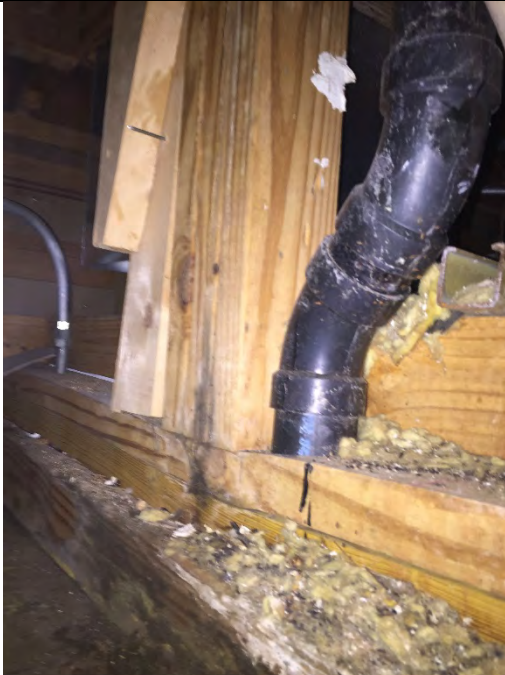
Photo 98

101. The west end of the beam was unattached to a large beam running north-south. *(Photo 98)*

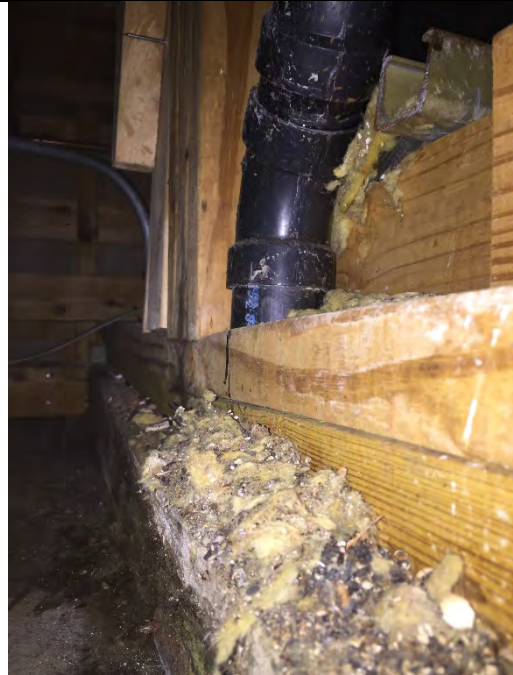
Photo 99

102. The north-south beam was found to be supported at the wall separating the men's and women's restrooms by 2x4 studs set on top of a double top plate. *(Photo 99)* (A plumbing pipe immediately to the east of the supports effectively cut the top plate in half at this point.)

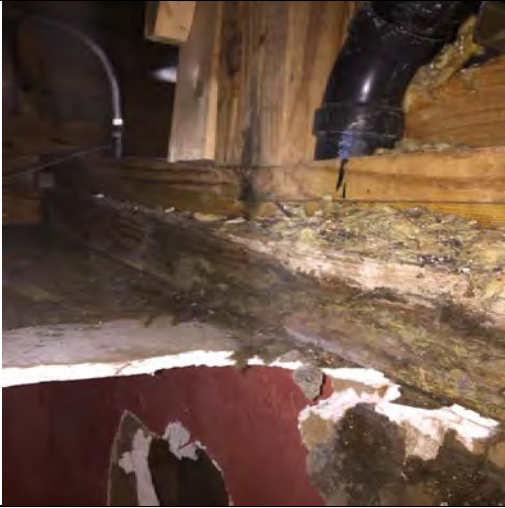
Photo 100

103. The top plate had deflected significantly. *(Photo 100)*

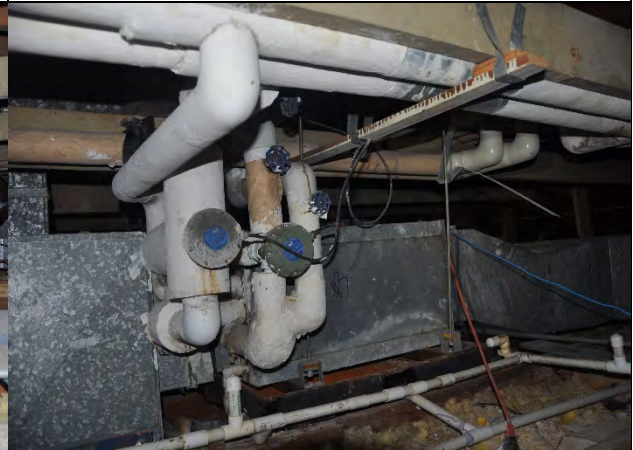
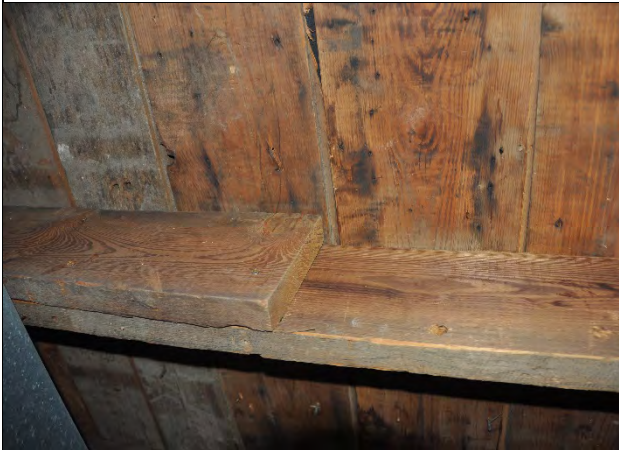
109. Abandoned HVAC equipment was observed in the attic. *(Photos 103, 104)*

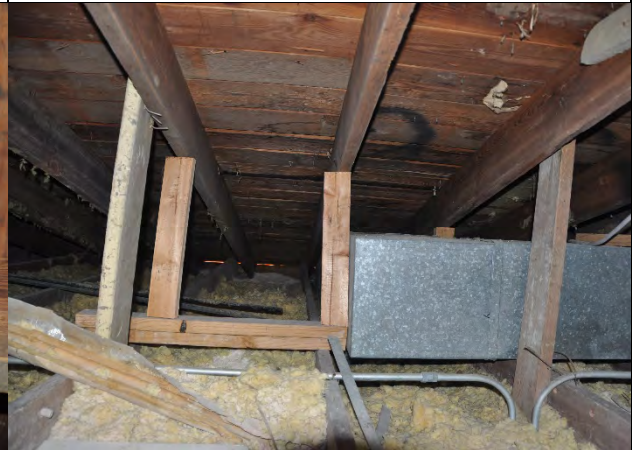
Photo 105

110. Roof decking is original lumber, and appeared to be in good condition where observed. *(Photo 105)*

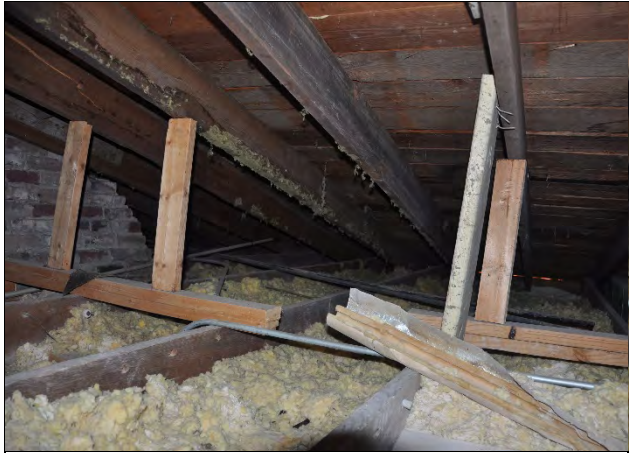
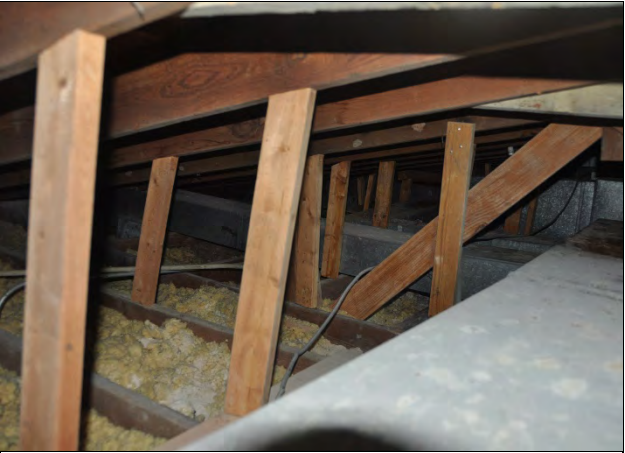
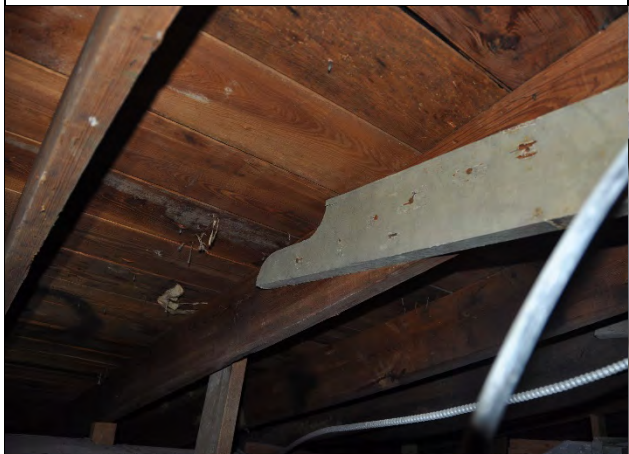
111. Additional bracing has been installed under the roof rafters in much of the observed attic space. *(Photos 106, 107, 108)*

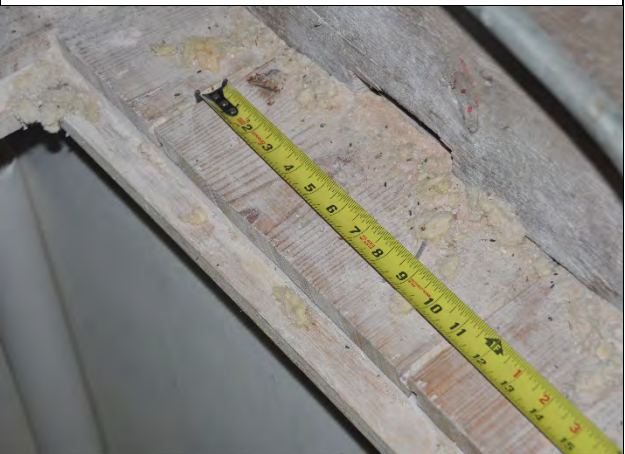
Photo 109

112. It appeared that some of the framing members in the attic space had been salvaged from other projects. *(Photo 109)* Note the green paint and the trellised end-cut. *(Also note that similar green painted wood was observed in other locations, such as the lower floor walls. It is unclear if the wood was a part of the original construction, or if it was used at a later date for repairs.)*

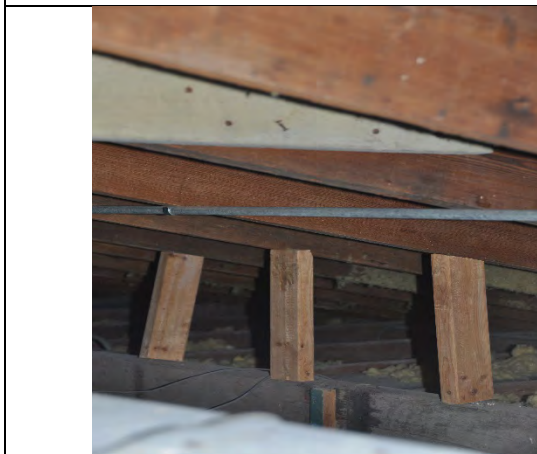
Photo 110

113. There is a wood plank ceiling installed directly to the ceiling joists, with a sheetrock ceiling below. *(Photo 110)*

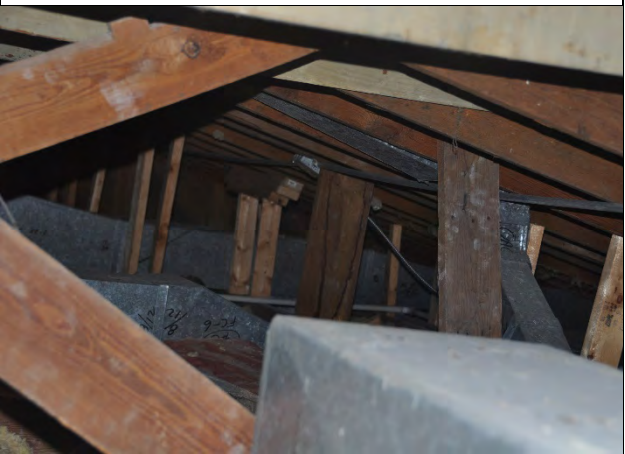
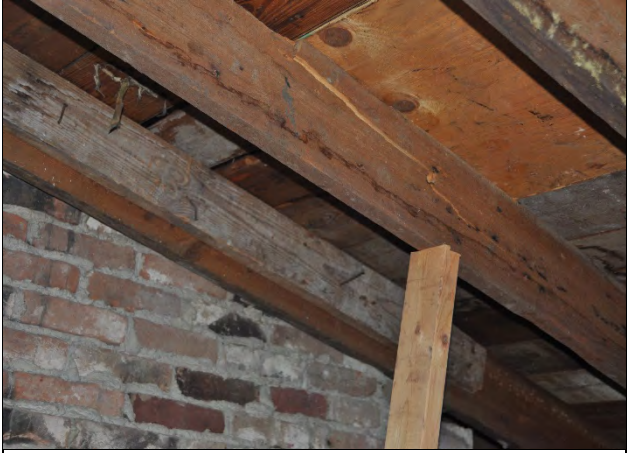
114. Additional added bracing was observed. *(Photos 111, 112)*
